City of Columbus

Stormwater NPDES Permit

January 1, 2018 – December 31, 2018
(Ohio EPA Permit Number: 4PI00000*CD)

ANNUAL REPORT

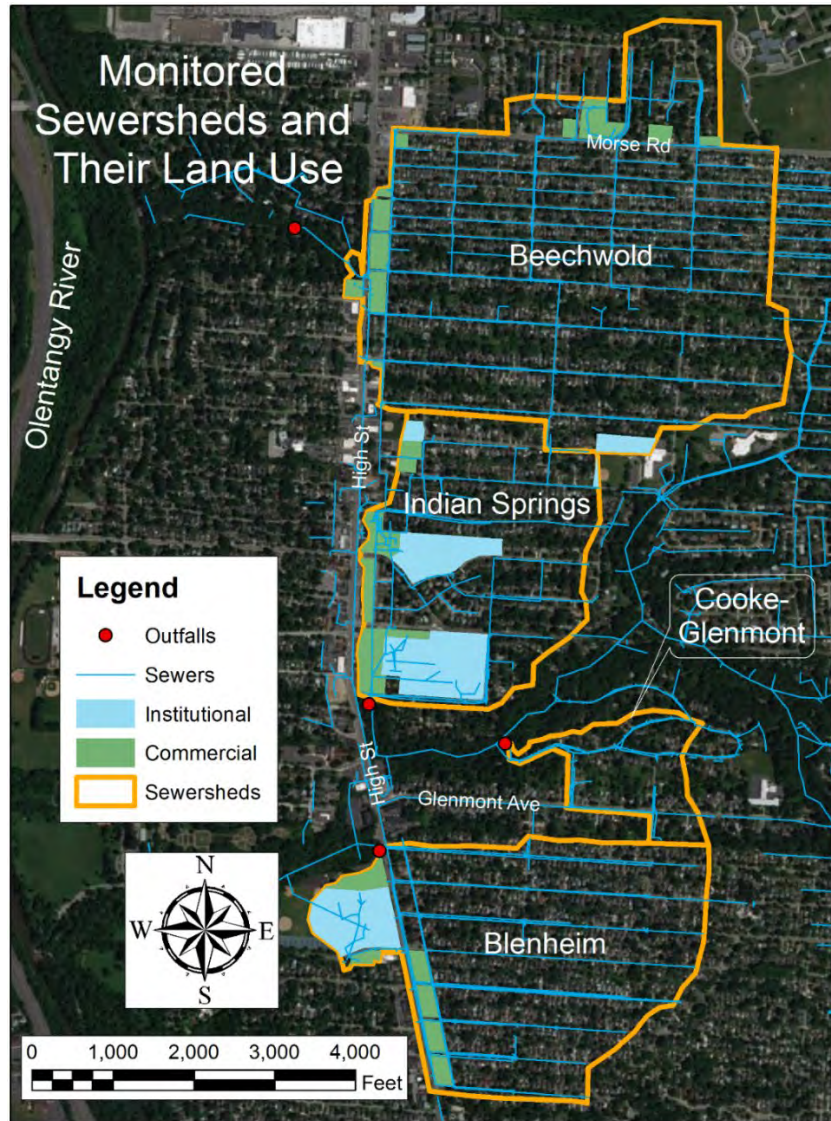
Figure 1. Boundaries of the four monitored sewersheds (orange) and land use within each sewershed. Commercial and institutional land uses are shown in blue and green polygons, respectively. All remaining land within each sewershed was residential.

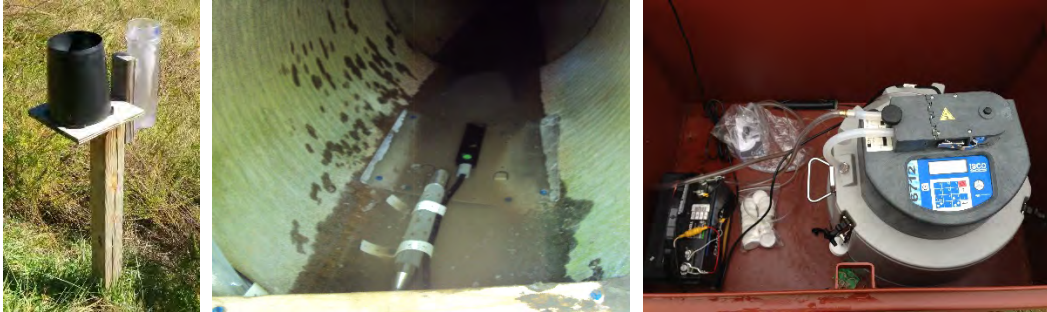
Figure 2. Rain gage setup (left), sample intake (clear plastic) and area velocity meter (black) in the Cooke-Glenmont outfall (center), and automated sampler at Beechwold (right).

A single rain gage cluster, consisting of a tipping bucket and a manual rain gage attached to a 6-ft tall wooden post, was located in each of the four experimental sewersheds (Figure 2). Rainfall data were collected using 0.01” resolution Davis Rain Collector tipping bucket rain gages (Davis Instruments, Hayward, California) and stored on Hobo Pendant data loggers (Onset Computer Corporation, Bourne, Massachusetts). Rainfall data were stored on a 1-minute interval and downloaded to a field laptop every three weeks. Manual rain gauges (Productive Alternatives, Fergus Falls, Minnesota) were checked after each rainfall event to re-calibrate sampler pacing. Rain gage clusters were installed in locations free from overhead obstructions.

The four sewersheds were instrumented to quantify hydrology during baseflow and stormflow and obtain representative samples of stormwater quality. Instrumentation was installed at outfalls draining each sewershed so that the total sewershed contribution was quantified (Figure 2). An ISCO 750 area velocity meter (AVM; Teledyne Isco, Lincoln, NE) was mounted to the bottom of the Beechwold and Cooke-Glenmont culverts and measured velocity and depth of flow. These sensors measure velocity by emitting a continuous ultrasonic wave that bounces off of particles and bubbles in the flow. The frequency shift in the returned signal (i.e. the Doppler Effect) is used to determine the average flow velocity. An internal pressure transducer in the AVM measures flow depth. These measurements along with the known outfall cross-section were used by ISCO 6712 samplers to determine flow rate on a 1-minute interval. At Blenheim and Indian Springs, AVMs transmitted measurements to ISCO 2150 flow modules. These data were stored in ISCO 2100 sample interface modules and used to trigger sample aliquots obtained by ISCO 3700 series samplers. Hydrologic data were downloaded every three weeks to a field laptop.

Runoff volume (i.e. flow) proportional, composite stormflow samples were collected by either ISCO 6712 or 3700 series samplers (Figure 2). Flow rates were integrated with time to determine stormwater volume and trigger sample aliquots. Aliquots were paced such that up to a 2-inch rainfall event could be effectively sampled; the runoff volume needed to trigger each aliquot was varied frequently based upon measured runoff volume and associated rainfall depth at a monitoring site. While flow from the Cooke-Glenmont outfall was ephemeral, the Beechwold, Blenheim, and Indian Springs outfalls had baseflow during inter-event periods. For outfalls with baseflow, an enable trigger based on flow depth was set to ensure the sampler did not count baseflow volume in the volumetric trigger for aliquot collection. Within each sampler, aliquots were composited in a single 10L bottle and thus characterized pollutant event mean concentrations (EMC).

All composite samples were composed of a minimum of five and a maximum of 50, 200 mL aliquots describing greater than 80% of the pollutograph (U.S. EPA 2002). All samples were collected within 24 hours of the cessation of rainfall. Sample strainers (Figure 2) were used to remove gross solids from the samples and located where flow was well-mixed.

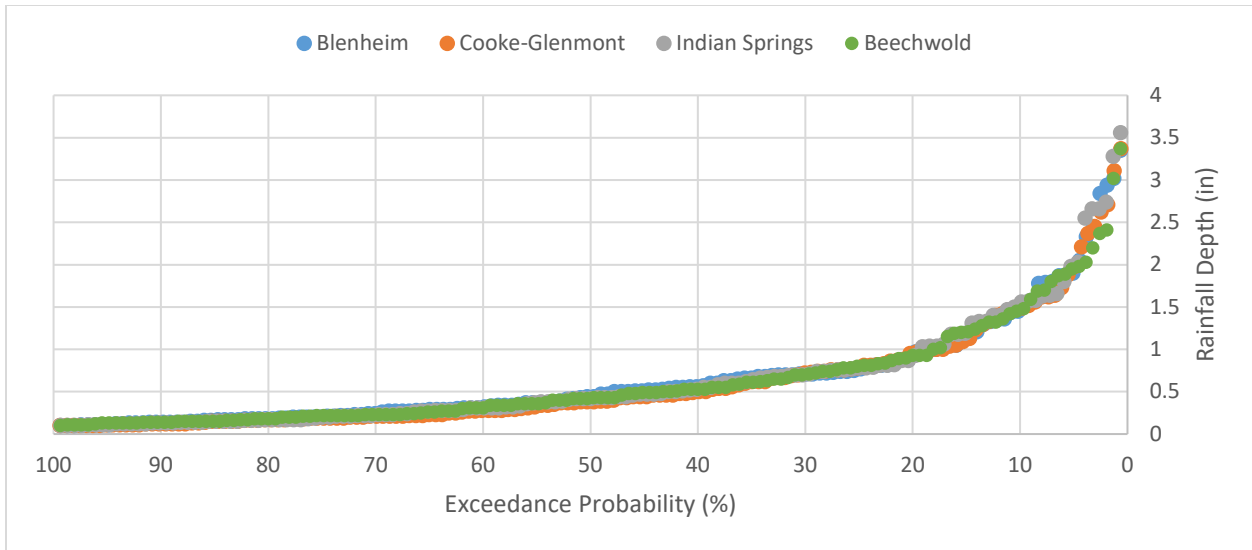
Figure 4. Exceedance probability of rainfall depths over the monitoring period for the four rain gauges in Clintonville.

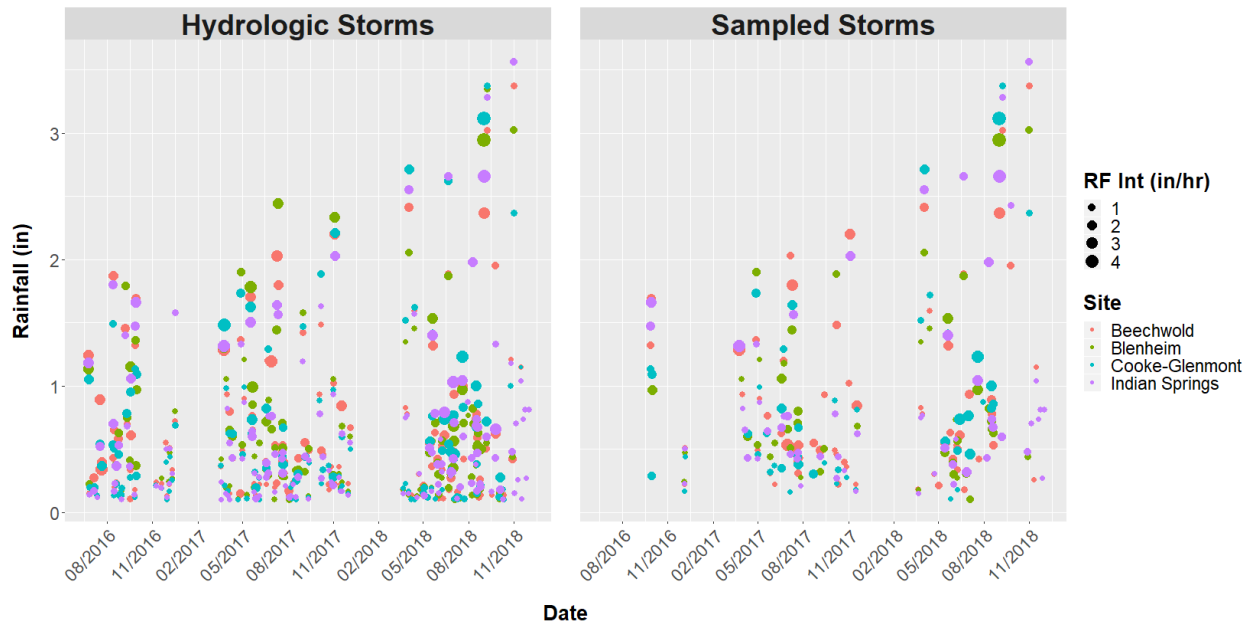
Figure 5. Rainfall depth and peak intensity for all observed and sampled storm events.

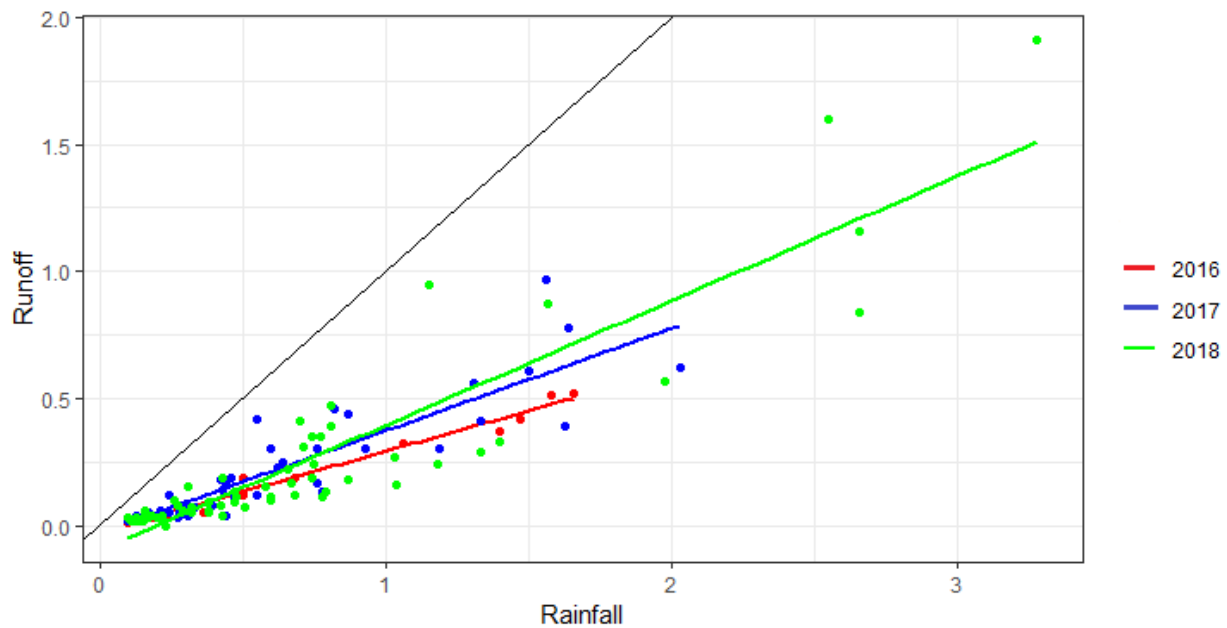
Figure 11. Stormwater runoff response for the Indian Springs sewershed during 2016-2018. The black line is the 1:1 line where all rainfall becomes runoff. Both rainfall and runoff are in inches.

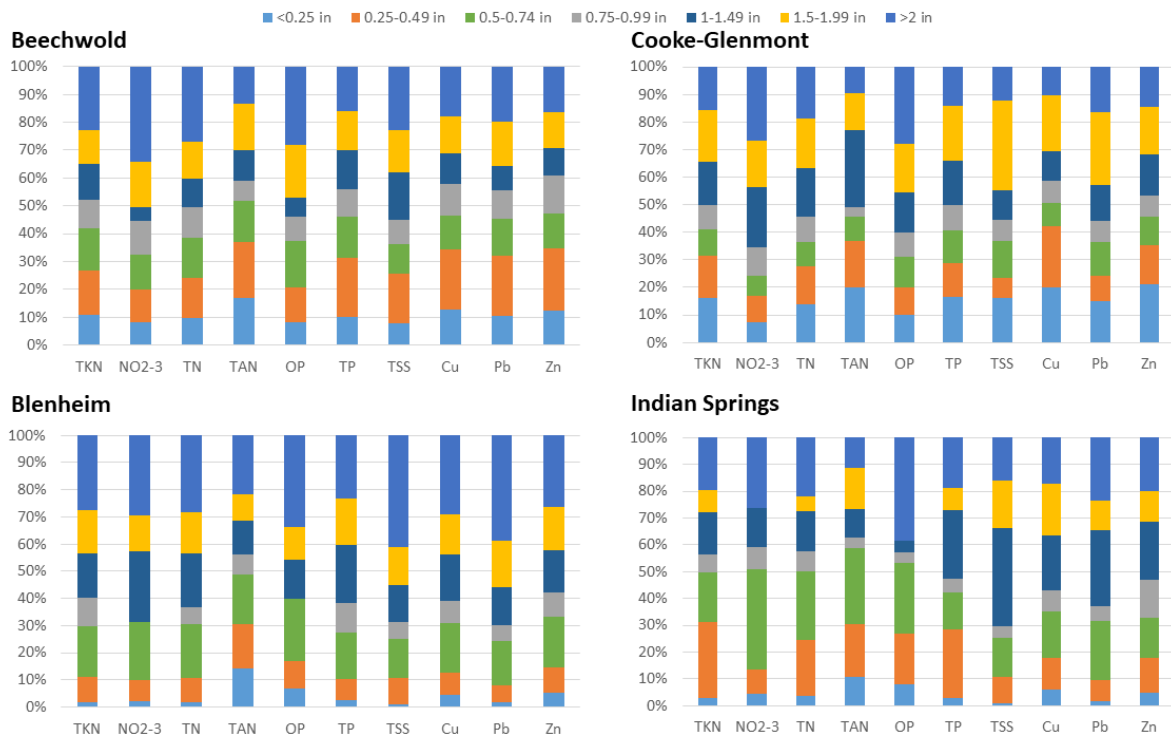
Figure 12. Contributions of various rainfall event depths to total pollutant load export from the four monitored sewersheds.

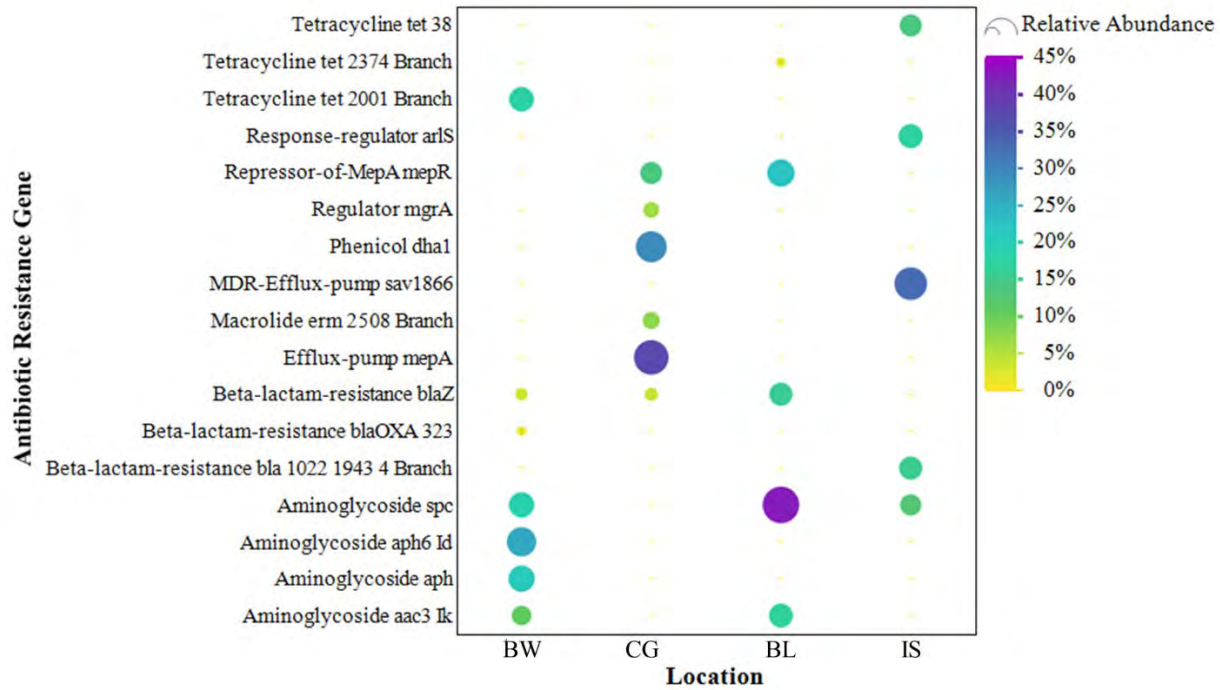
Figure 19. Profile of relative abundance of antibiotic resistance genes (resistome) across sampling location.

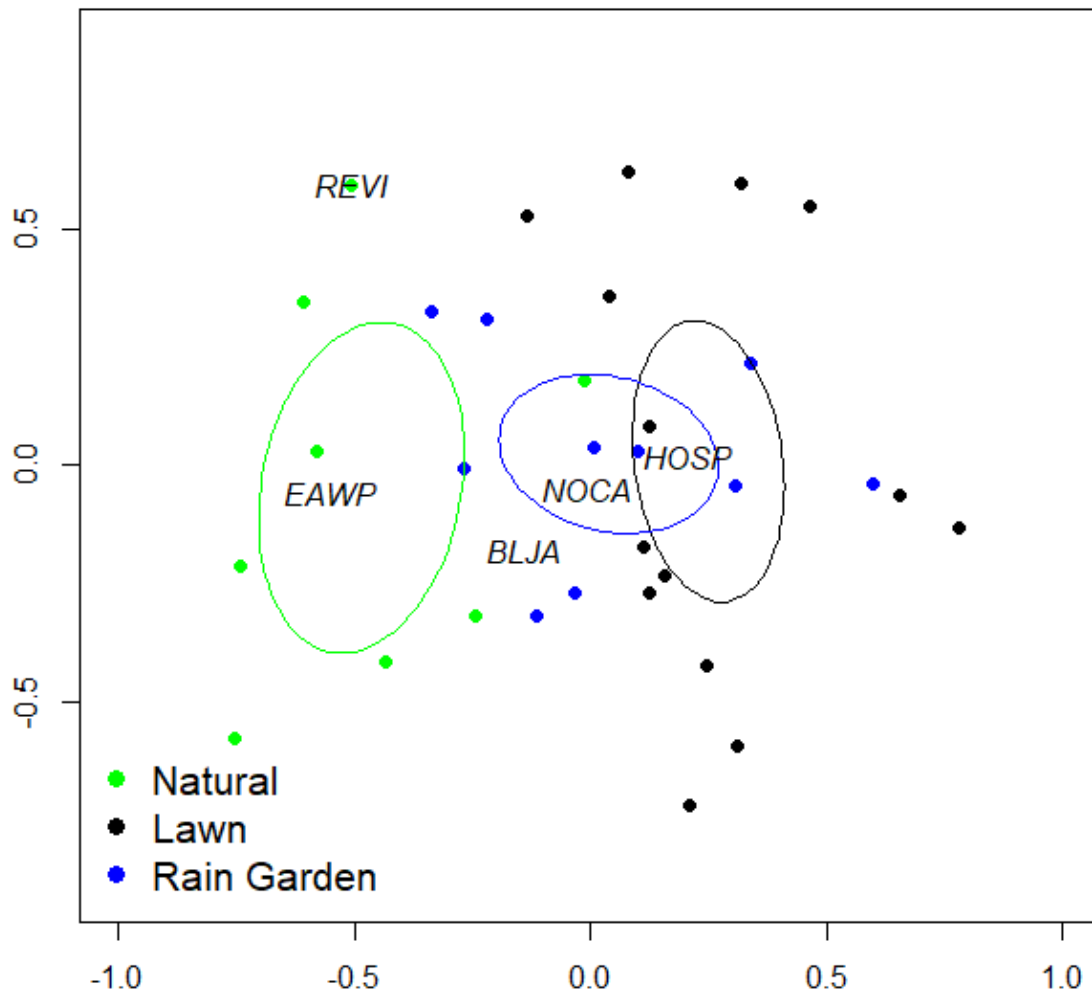
Figure 21. Ordination plot (NMDS) of community diversity shows that natural sites (green dots) are more similar to each other than to lawn areas (black dots) (ANOSIM, $p = 0.001$). Rain gardens (blue dots) currently bridge these two types in terms of overall community composition. Species are plotted based on how they associate with sites: some species appear preferentially in natural areas while other associate with lawn areas. EAWP = Eastern Wood-Pewee, REVI = Red-eyed Vireo, BLJA = Blue Jay, NOCA = Northern Cardinal, HOSP = House Sparrow. Data are presence/absence only, and collected from a small number of hand-identified files. Axes are composites of response variables and have no ready physical interpretation, but are chosen to display variation between sites.

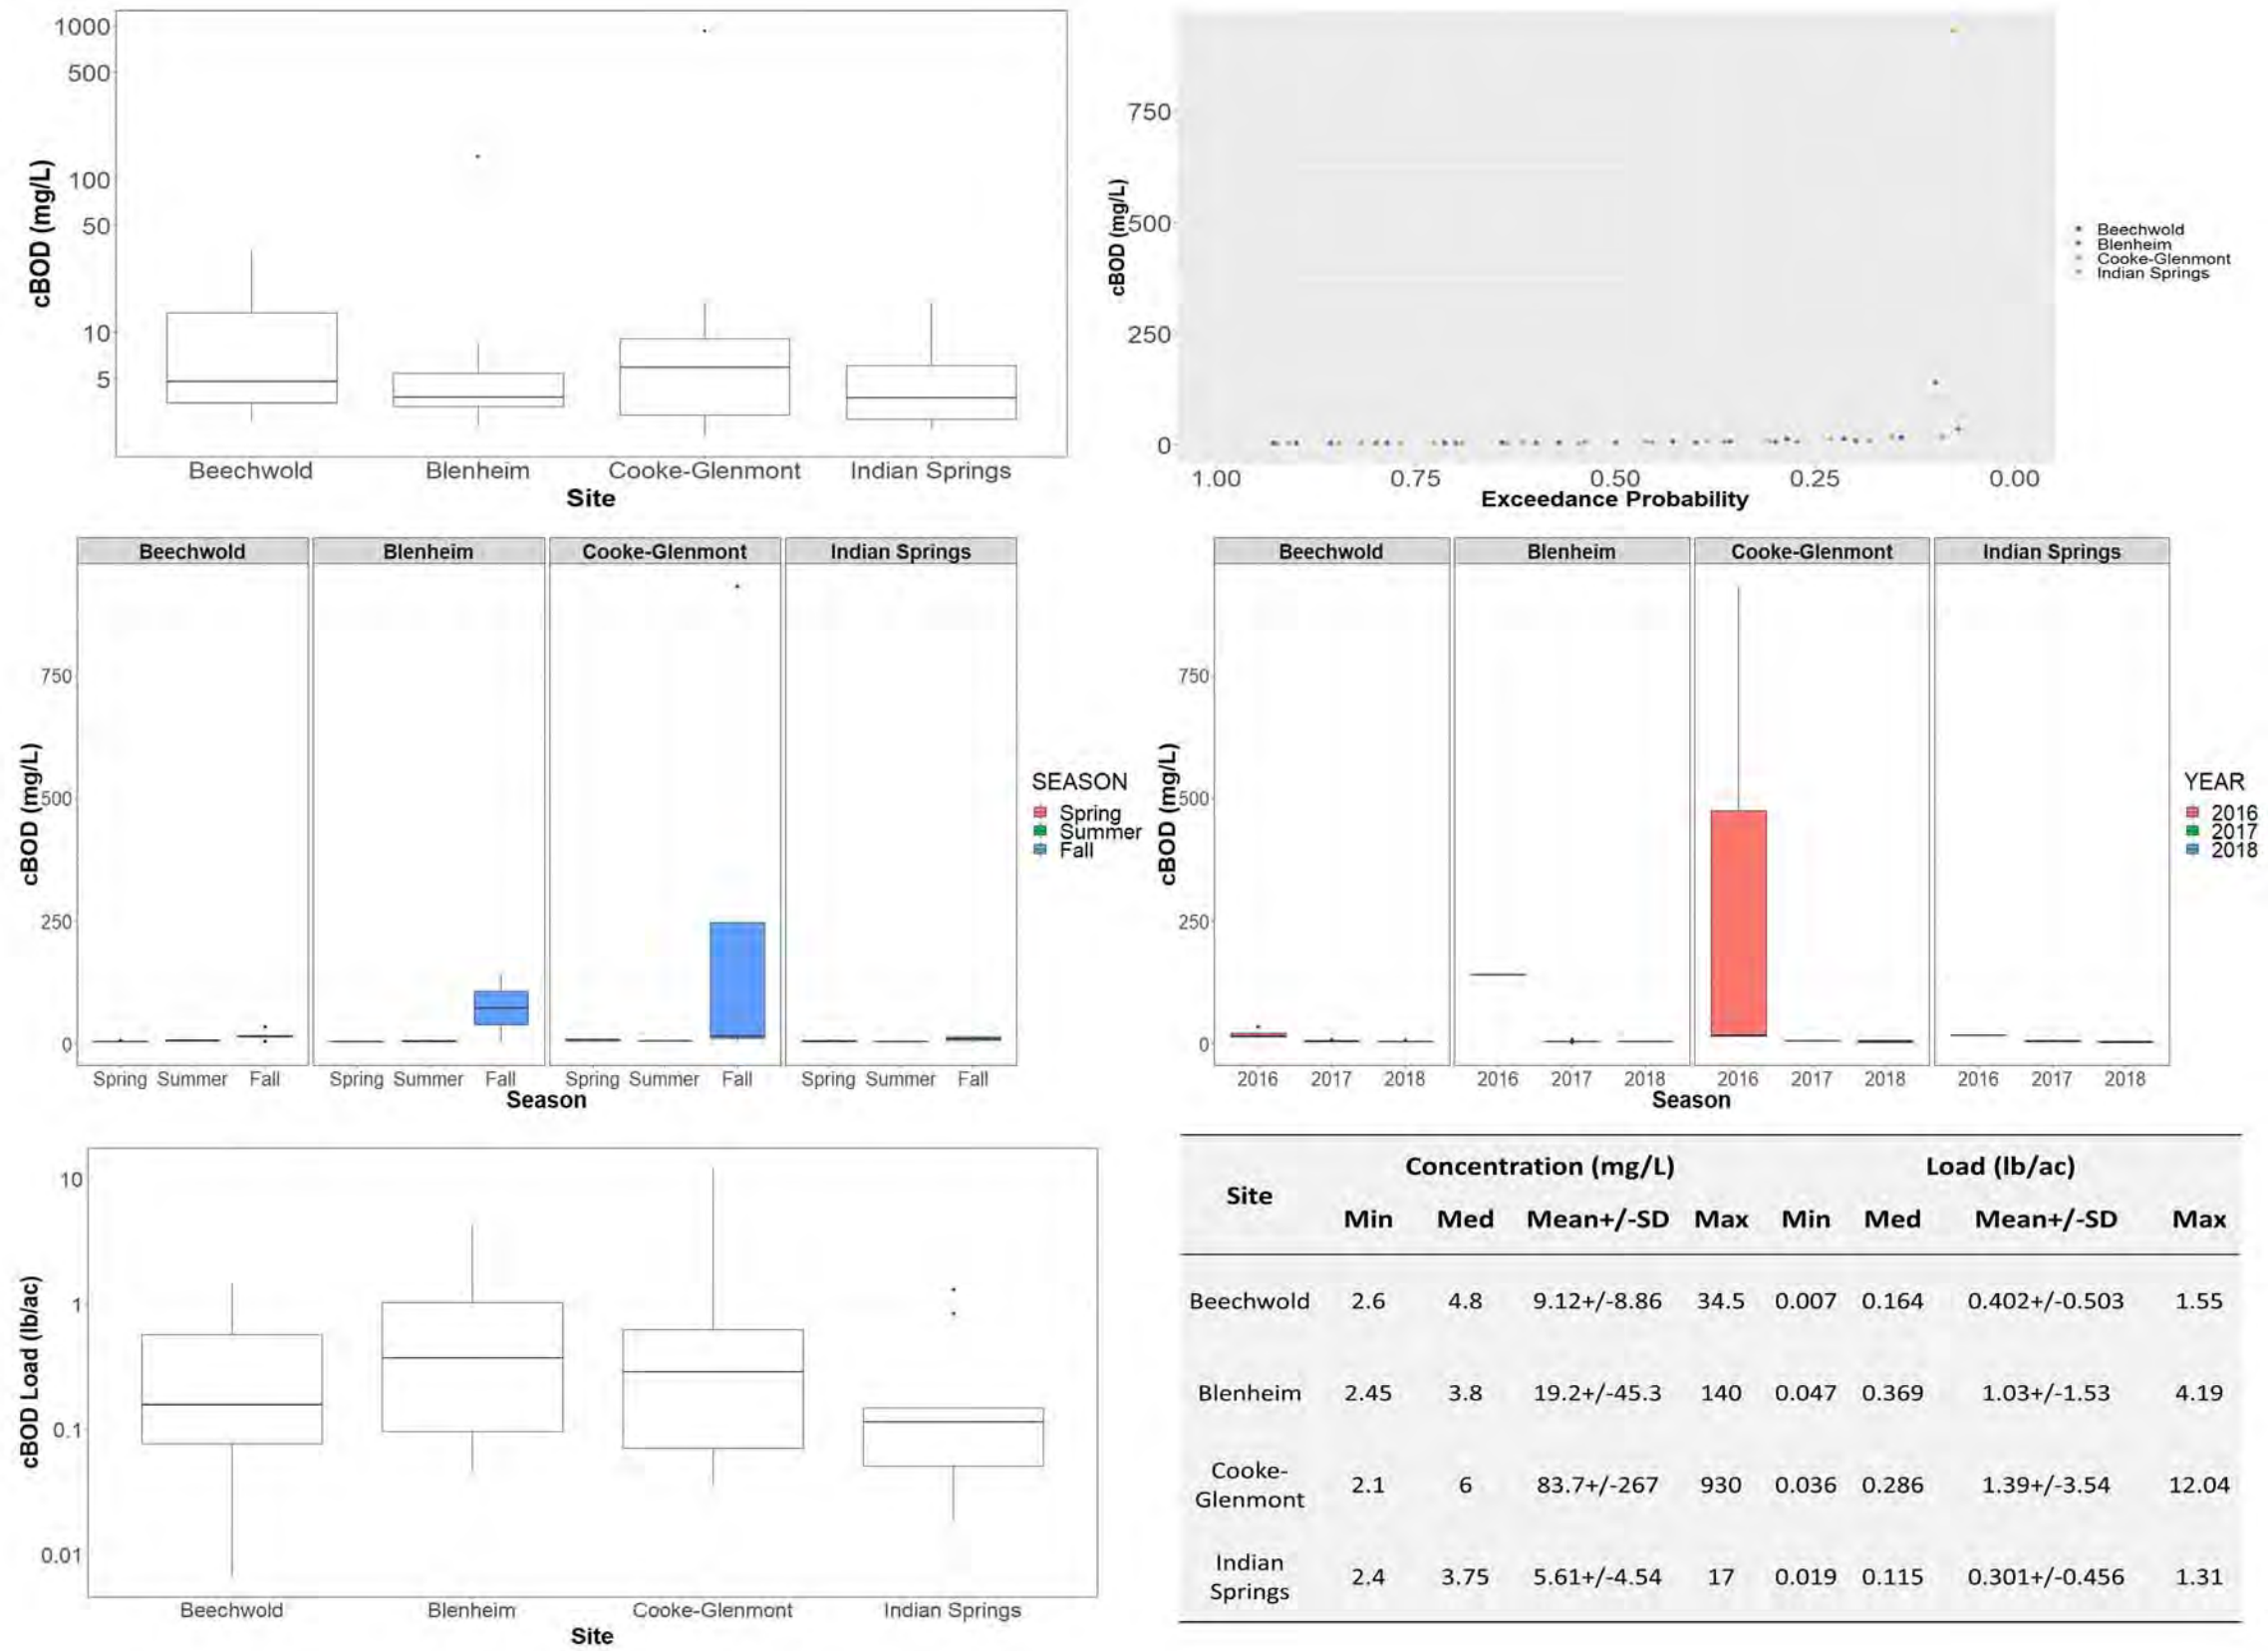
Figure 41. Boxplots of cBOD concentration and sewershed area normalized load for sampled storm events, exceedance probability plots of cBOD concentration, seasonal and annual boxplots for cBOD concentration, and summary statistics of cBOD concentration and load for the four monitored sewersheds.
