Bliss Run, Lower Alum Creek Watershed

City of Columbus
Stormwater NPDES Permit

January 1, 2019 – December 31, 2019
(Ohio EPA Permit Number: 4PI00000*CD)

ANNUAL REPORT

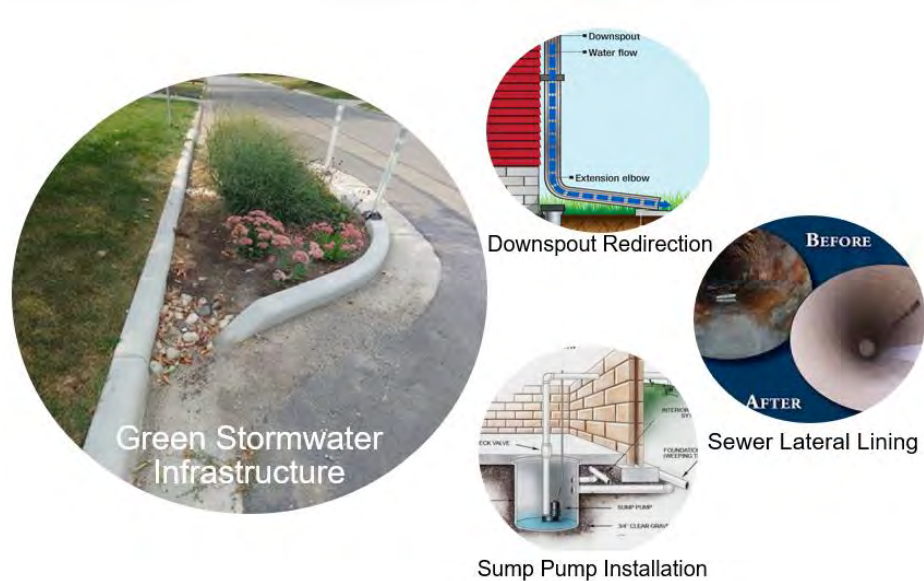
Figure 1. Four pillars of the Blueprint Columbus project.

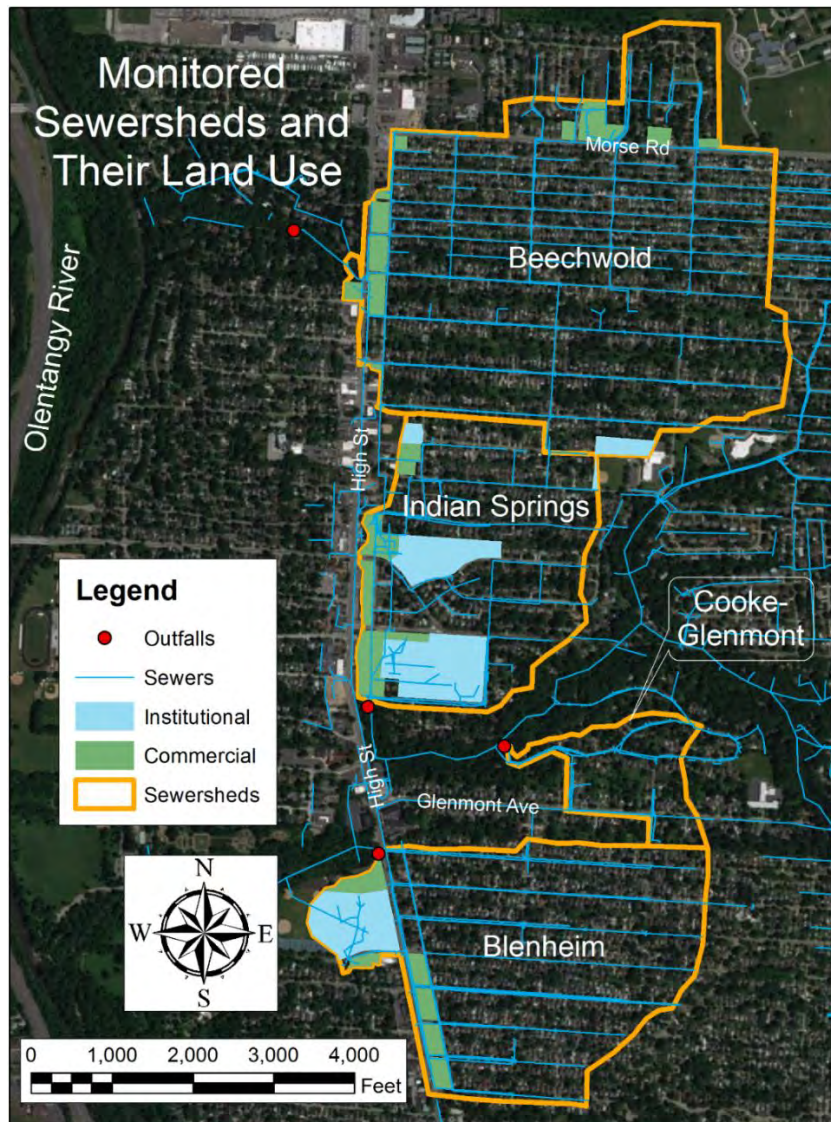
Figure 2. Boundaries of the four monitored sewersheds (orange) and land use within each sewershed. Commercial and institutional land uses are shown in blue and green polygons, respectively. All remaining land within each sewershed was residential.

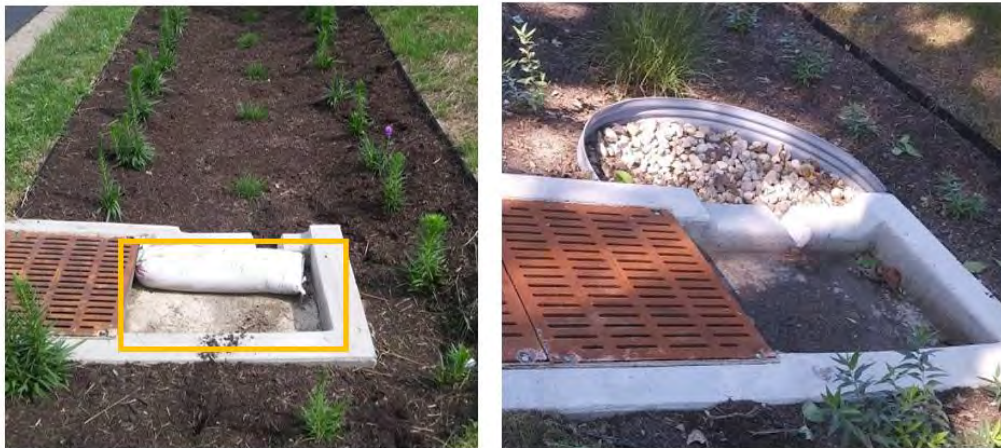
Figure 5. Bioretention cell with sandbag blocking the inlet and the same cell after sandbag was removed and runoff from street was routed into the practice. Blocking of the inlet structures preventing high-intensity runoff events from entering the practice immediately following planting to allow juvenile plants to become established in the bioretention media.

The GI construction phase encompassed the three phases of GI retrofitting: construction, planting, and establishment. During the establishment phase, runoff was routed away from the BRCs to provide a period for plants to establish (Figure 5). As of December 2019, the Indian Springs sewershed was fully completed with respect to the four pillars of Blueprint Columbus. In August 2019, the post-Blueprint period began in this sewershed. Unlike the other treatment sewersheds, a respite in construction between GI implementation and the other three pillars did not occur. Thus, in order to provide a sufficient number of storm events permitting a comparison to the other treatment sewersheds (where the effects of GI were able to be isolated), the Post-GI retrofit period for Indian Springs includes the installation of other phases of the Blueprint Columbus project. Conversely, time periods relating to the construction of GI and installation of other Blueprint Columbus activities were excluded from the datasets for the other treatment sewersheds, as previously noted.

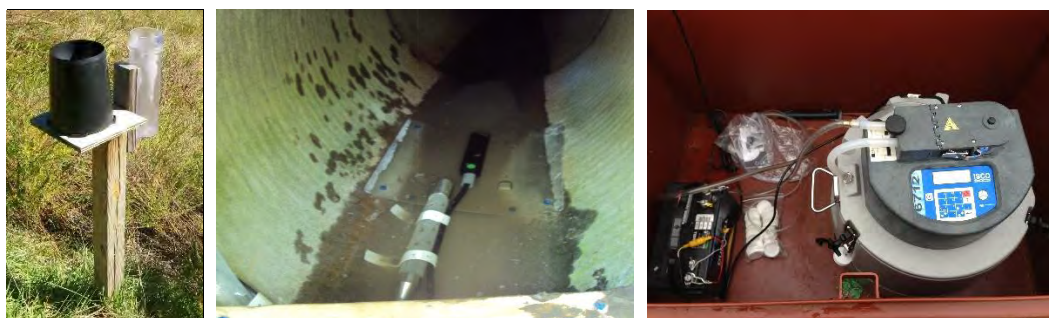
Figure 6. Rain gage setup (left), sample intake (clear plastic) and area velocity meter (black) in the Cooke-Glenmont outfall (center), and automated sampler at Beechwold (right).

A single rain gage cluster, consisting of a tipping bucket and a manual rain gage attached to a 6-ft tall wooden post, was located in each of the four monitored sewersheds (Figure 6). Rainfall data were collected using 0.01” resolution Davis Rain Collector tipping bucket rain gages (Davis Instruments, Hayward, California) and stored on Hobo Pendant data loggers (Onset Computer Corporation, Bourne, Massachusetts). Rainfall data were stored on a 1-minute interval and downloaded to a field laptop every three weeks. Readings from manual rain gages (Productive Alternatives, Fergus Falls, Minnesota) were observed after each rainfall event to re-calibrate sampler pacing. Rain gage clusters were installed in locations free from overhead obstructions.

The four sewersheds were instrumented to quantify hydrology during baseflow and stormflow and obtain representative samples of stormwater quality. Instrumentation was installed at outfalls draining each sewershed so that the total sewershed contribution was quantified (Figure 6). An ISCO 750 area velocity meter (AVM; Teledyne Isco, Lincoln,

Runoff volume-proportional, composite stormflow samples were collected by either ISCO 6712 or 3700 series samplers (Figure 6). Flow rates were integrated with time to determine stormwater volume and trigger sample aliquots. Aliquots were paced such that up to a 2-inch rainfall event could be effectively sampled; the runoff volume needed to trigger each aliquot was varied frequently based upon measured runoff volume and associated rainfall depth at a monitoring site. While flow from the Cooke-Glenmont outfall was ephemeral, the Beechwold, Blenheim, and Indian Springs outfalls had baseflow during inter-event periods. For outfalls with baseflow, an enable trigger based on flow depth was set to ensure the sampler did not consider baseflow volume in the volumetric trigger for aliquot collection. Within each sampler, aliquots were composited in a single 18.9L bottle and thus characterized pollutant event mean concentrations (EMC).

collected within 24 hours of the cessation of rainfall. Sample strainers (Figure 6) were used to remove gross solids from the samples and were located where flow was well-mixed.

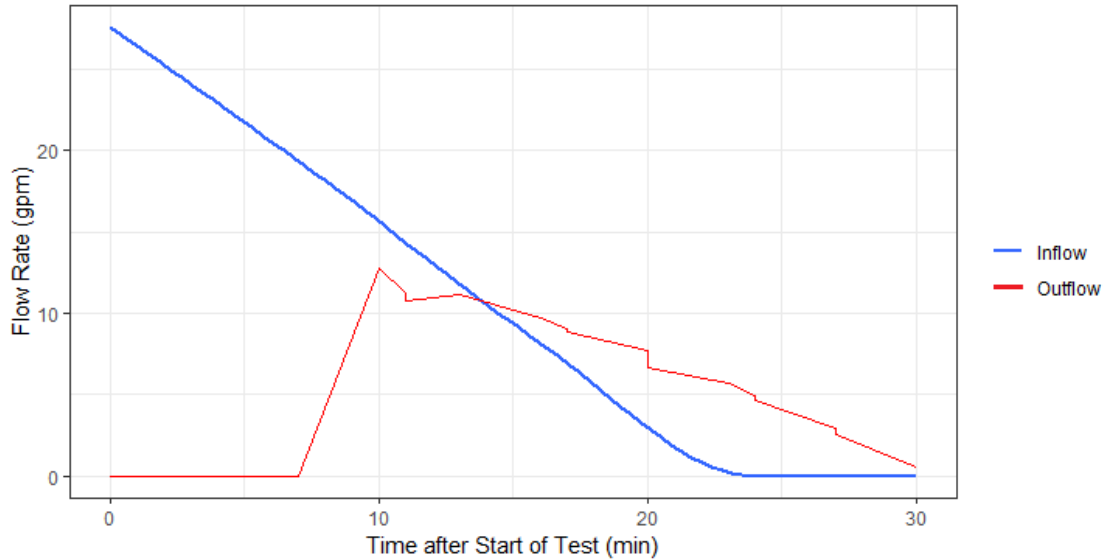
Figure 10. Example hydrograph from July 2018 simulated storm testing at a bioretention cell at the corner of Schreyer and Shields Place.

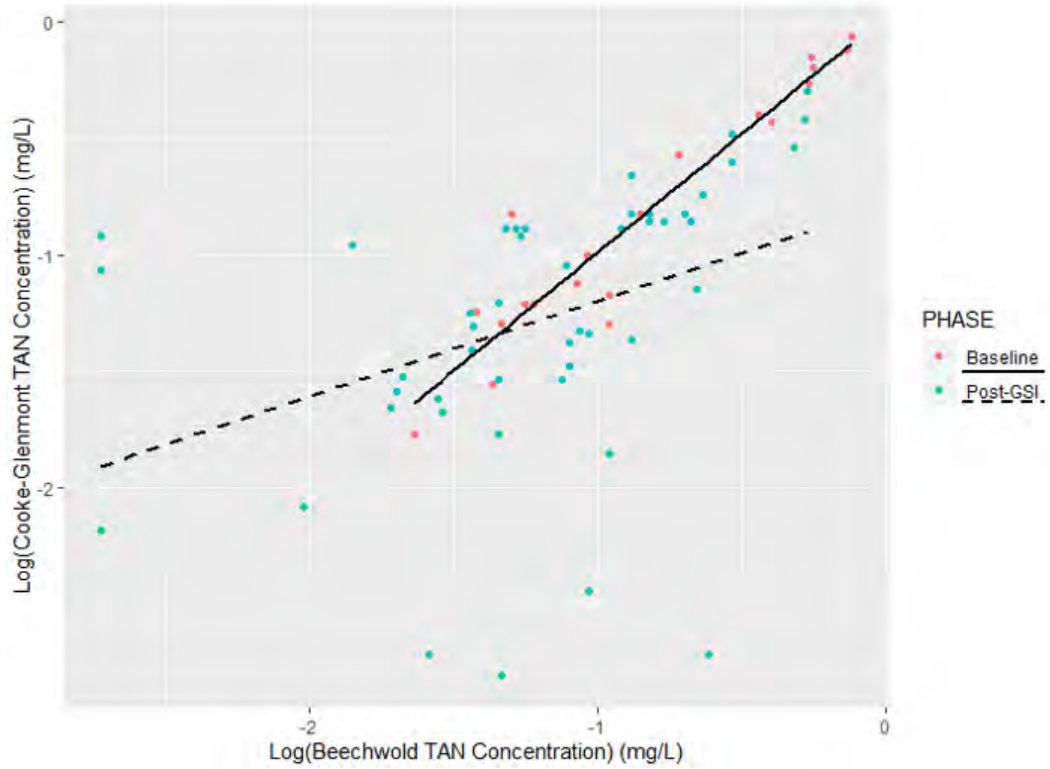
Figure 11. ANCOVA analysis for TAN concentration at Cooke-Glenmont. A significant difference was observed in the intercepts for TAN concentrations between Baseline and post-GI phases.

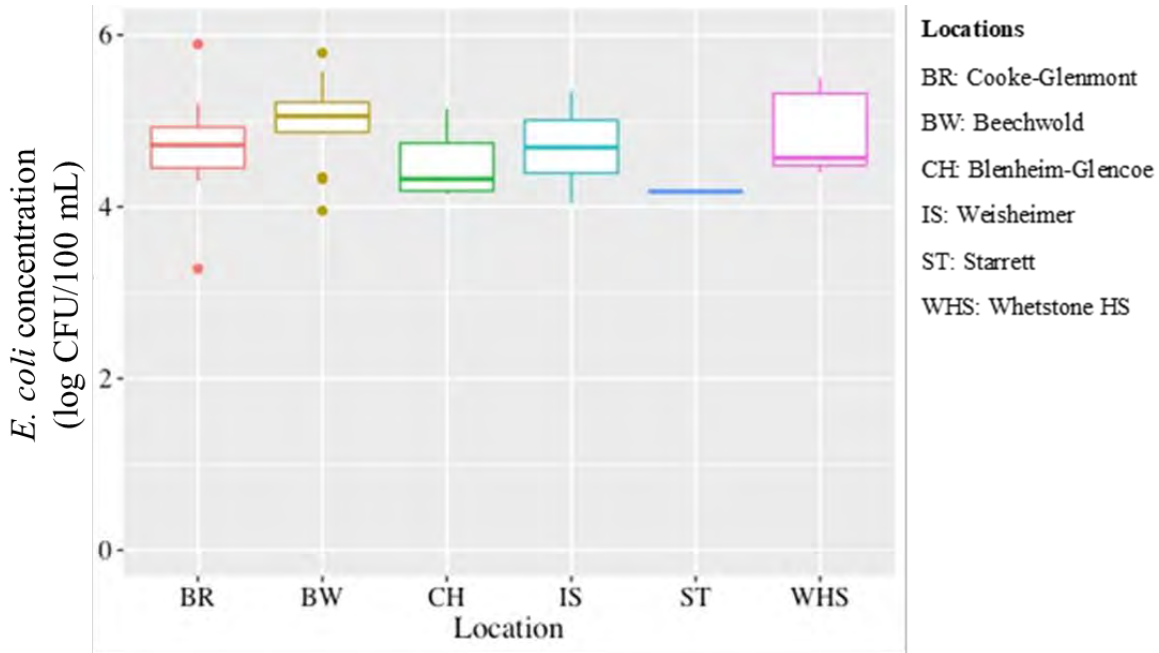
Figure 14. Mean concentration of *E. coli* (log CFU/100mL) for each sewershed.

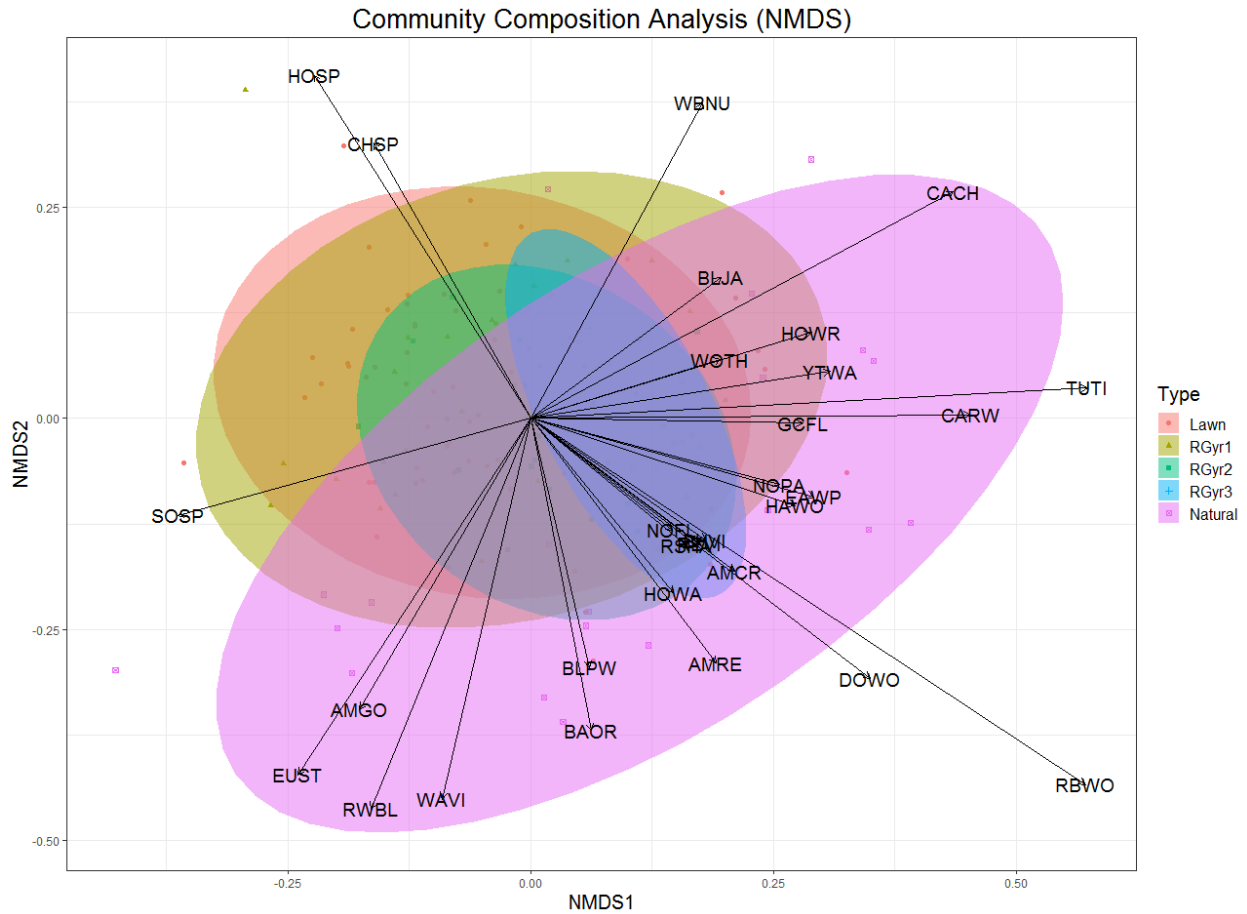
Figure 20. nMDS plot of sites arranged based on species observed.
