**RE: *City of Columbus Stormwater Drainage Manual (SWDM) Type III Variance Request
Proposed Buckeye Rail Yard Redevelopment
4882 Trabue Road, Columbus, Franklin County, Ohio 43228***

City of Columbus Type III Variance Application

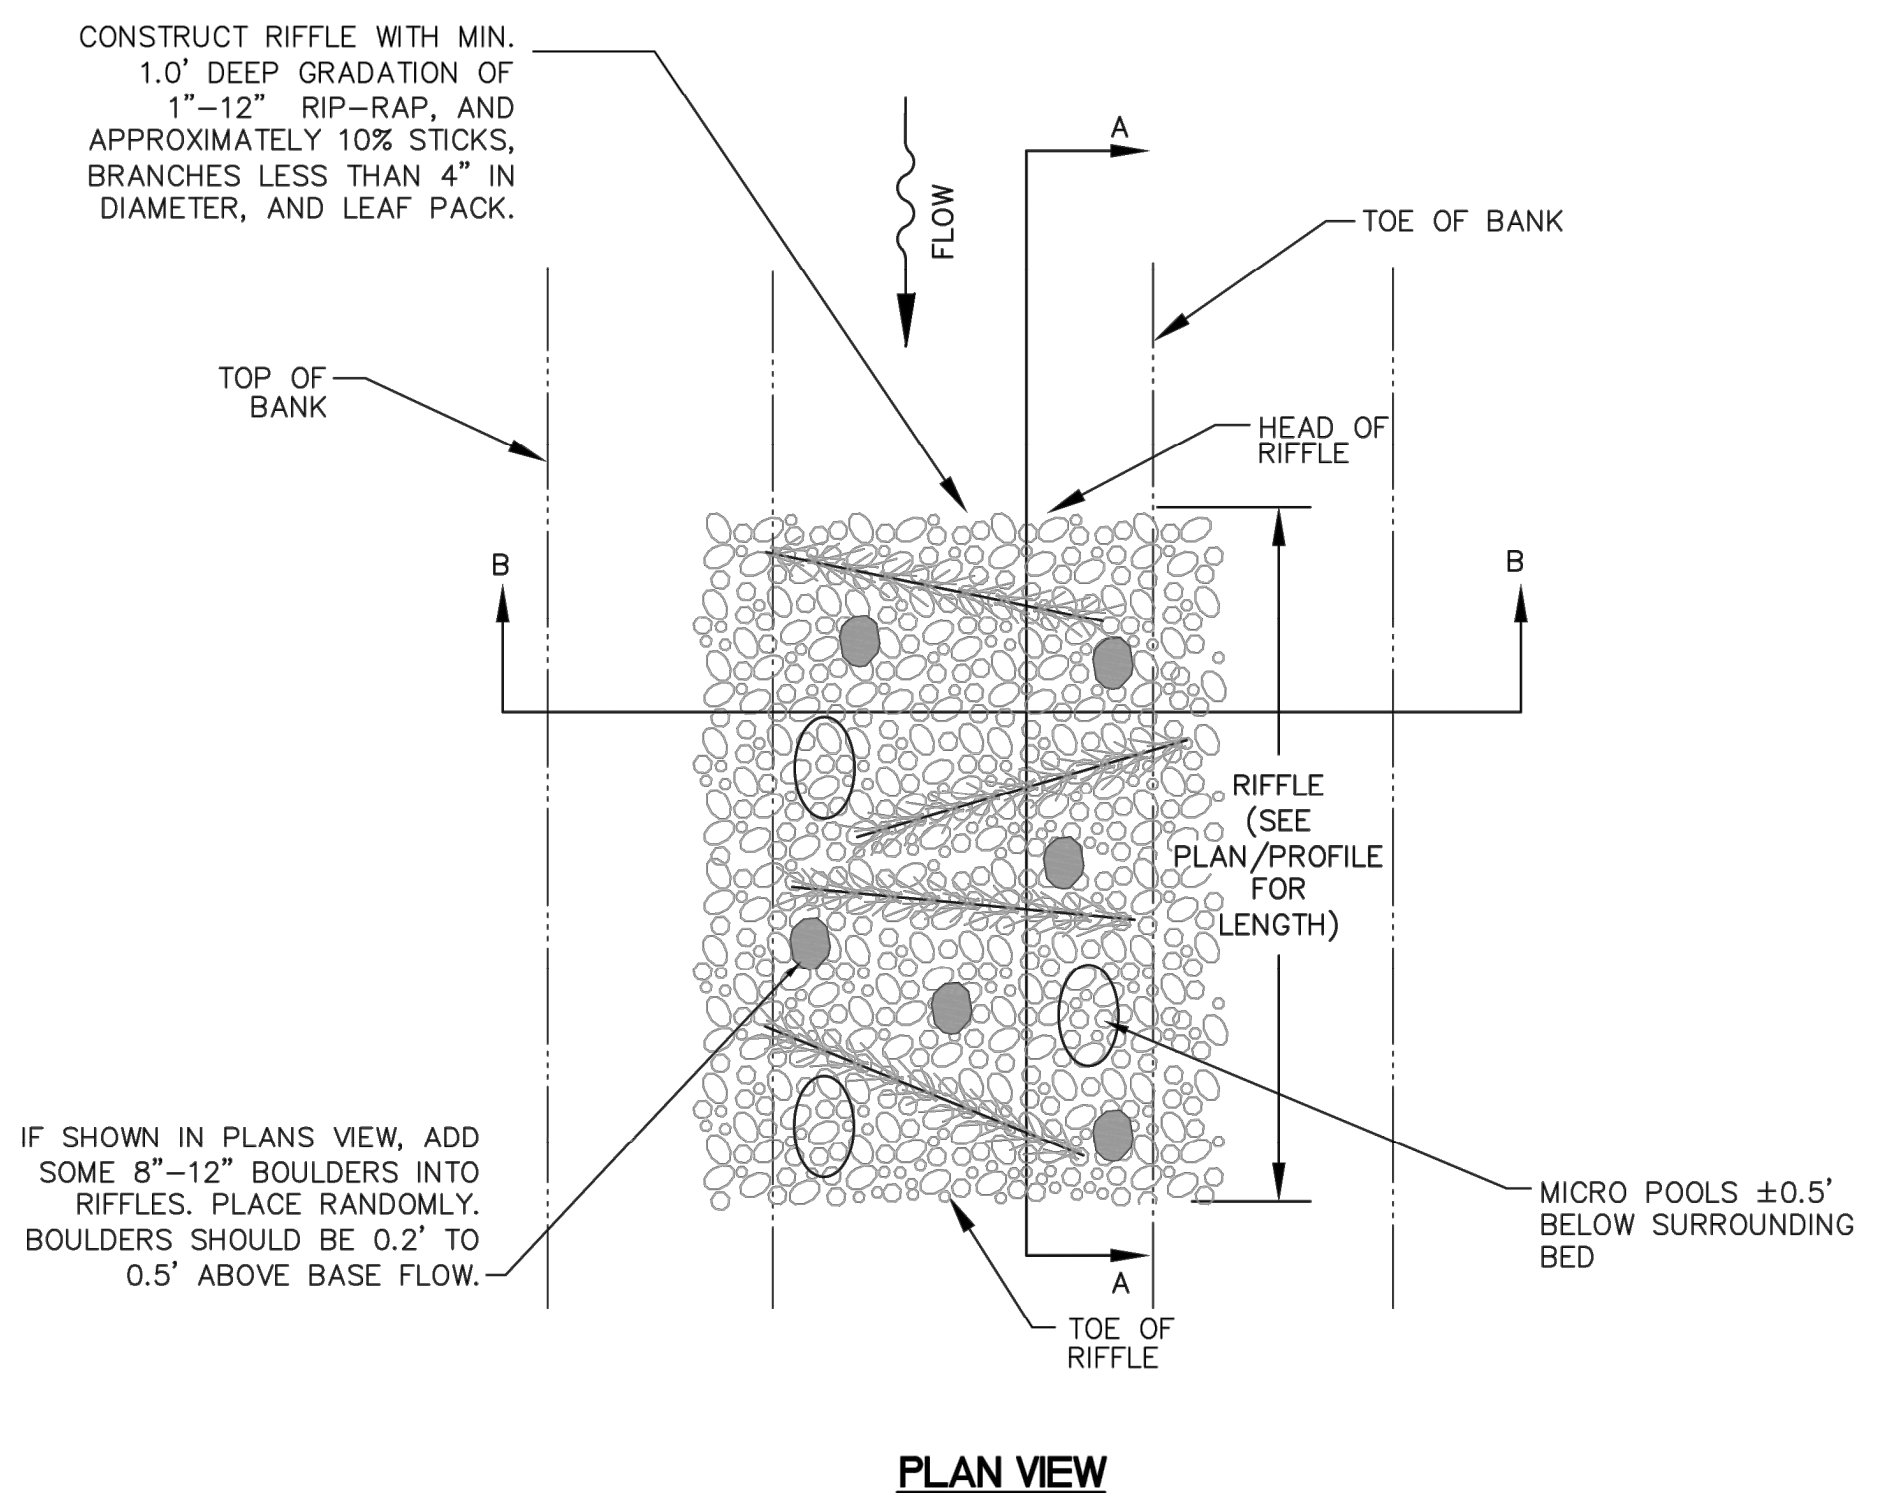
- NOTES:
1. MAJORITY OF BRUSH SHOULD BE AT 0.5"-2.0" IN DIAMETER AND NO LARGER THAN 6" AND EXTEND INTO THE BANK 2 FEET ON EACH SIDE. WOOD MATERIAL SHALL BE VARYING DIAMETER TO ALLOW MATERIAL TO BE COMPACTED.

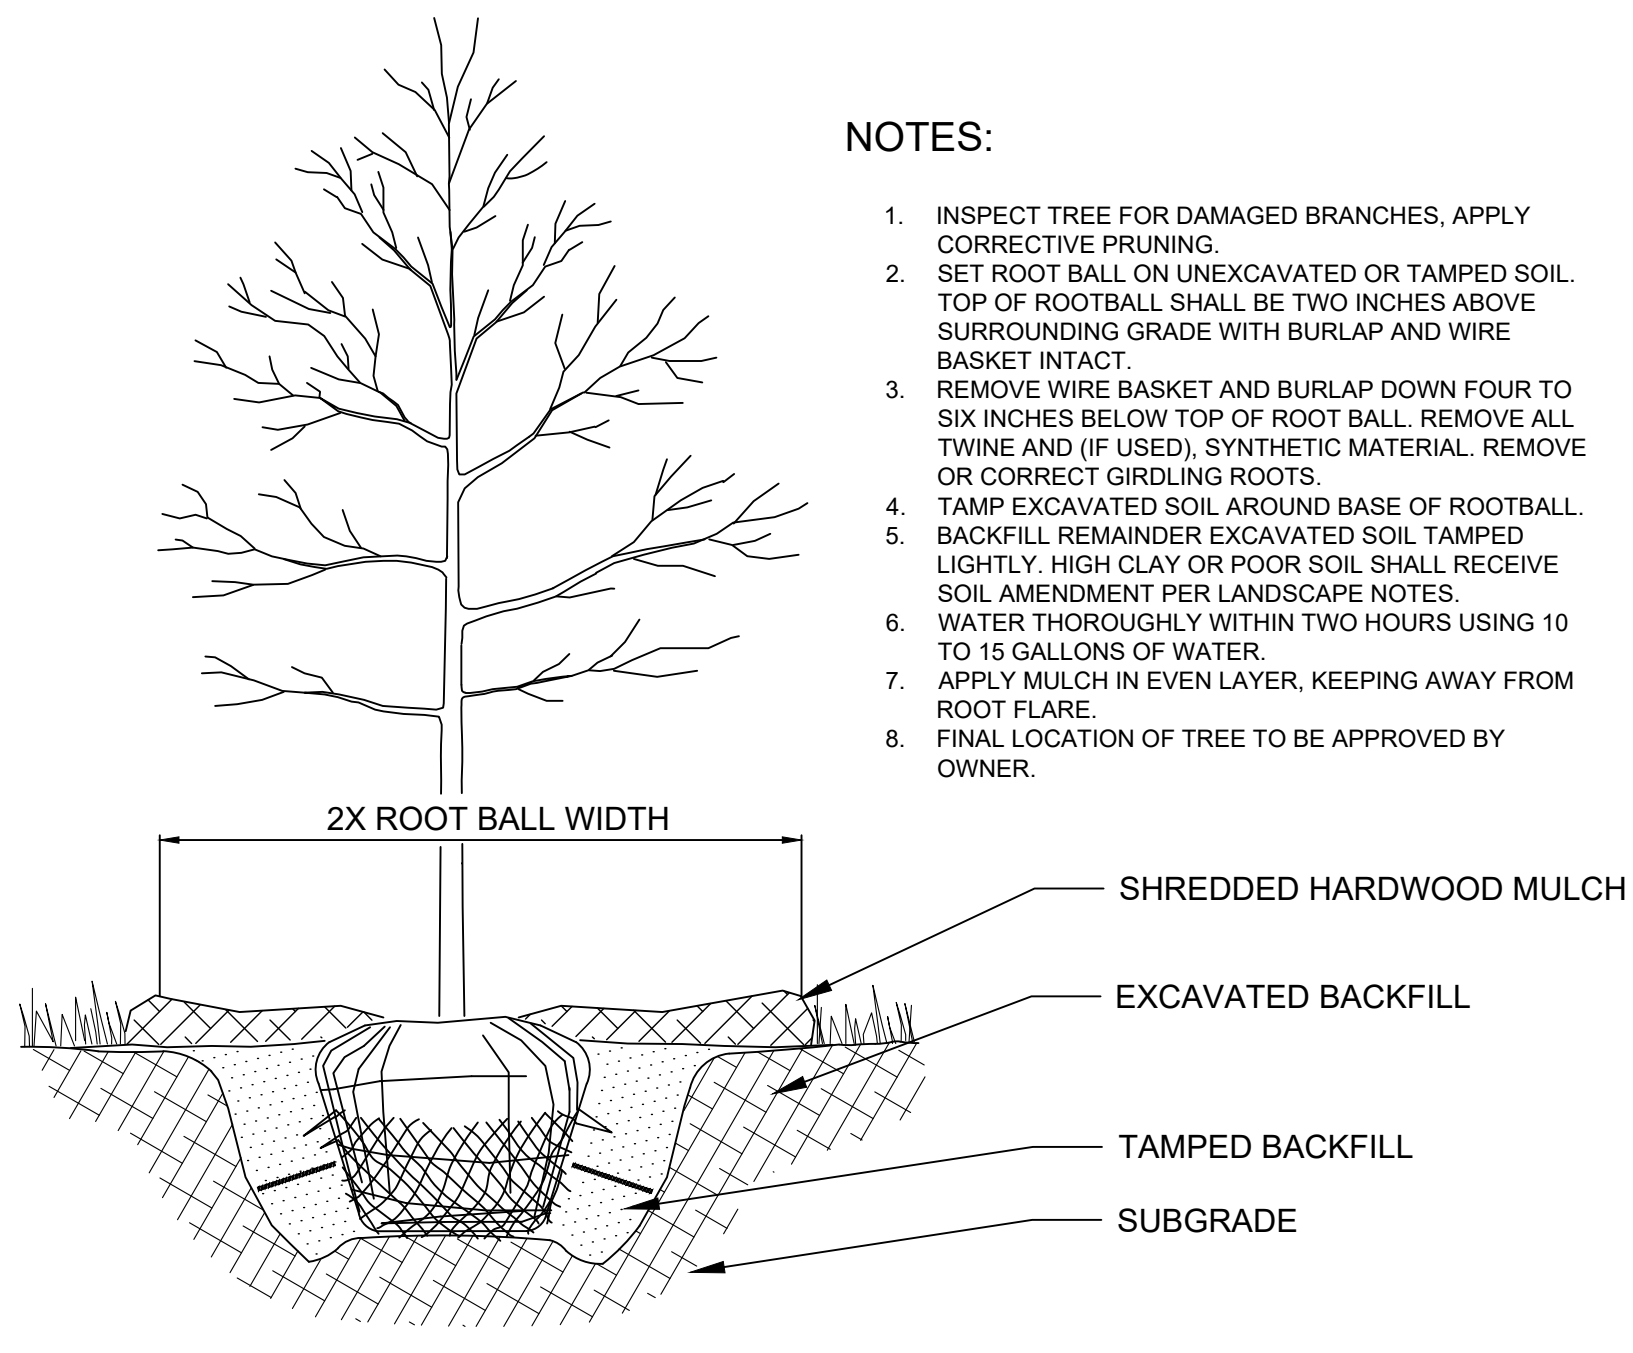
TREE PLANTING DETAIL
NOT TO SCALE

- NOTES:**
1. INSPECT TREE FOR DAMAGED BRANCHES, APPLY CORRECTIVE PRUNING.
 2. SET ROOT BALL ON UNEXCAVATED OR TAMPED SOIL. TOP OF ROOTBALL SHALL BE TWO INCHES ABOVE SURROUNDING GRADE WITH BURLAP AND WIRE BASKET INTACT.
 3. REMOVE WIRE BASKET AND BURLAP DOWN FOUR TO SIX INCHES BELOW TOP OF ROOT BALL. REMOVE ALL TWINE AND (IF USED), SYNTHETIC MATERIAL. REMOVE OR CORRECT GIRDLING ROOTS.
 4. TAMP EXCAVATED SOIL AROUND BASE OF ROOTBALL. BACKFILL REMAINDER EXCAVATED SOIL TAMPED LIGHTLY. HIGH CLAY OR POOR SOIL SHALL RECEIVE SOIL AMENDMENT PER LANDSCAPE NOTES.
 5. WATER THOROUGHLY WITHIN TWO HOURS USING 10 TO 15 GALLONS OF WATER.
 6. APPLY MULCH IN EVEN LAYER, KEEPING AWAY FROM ROOT FLARE.
 7. FINAL LOCATION OF TREE TO BE APPROVED BY OWNER.

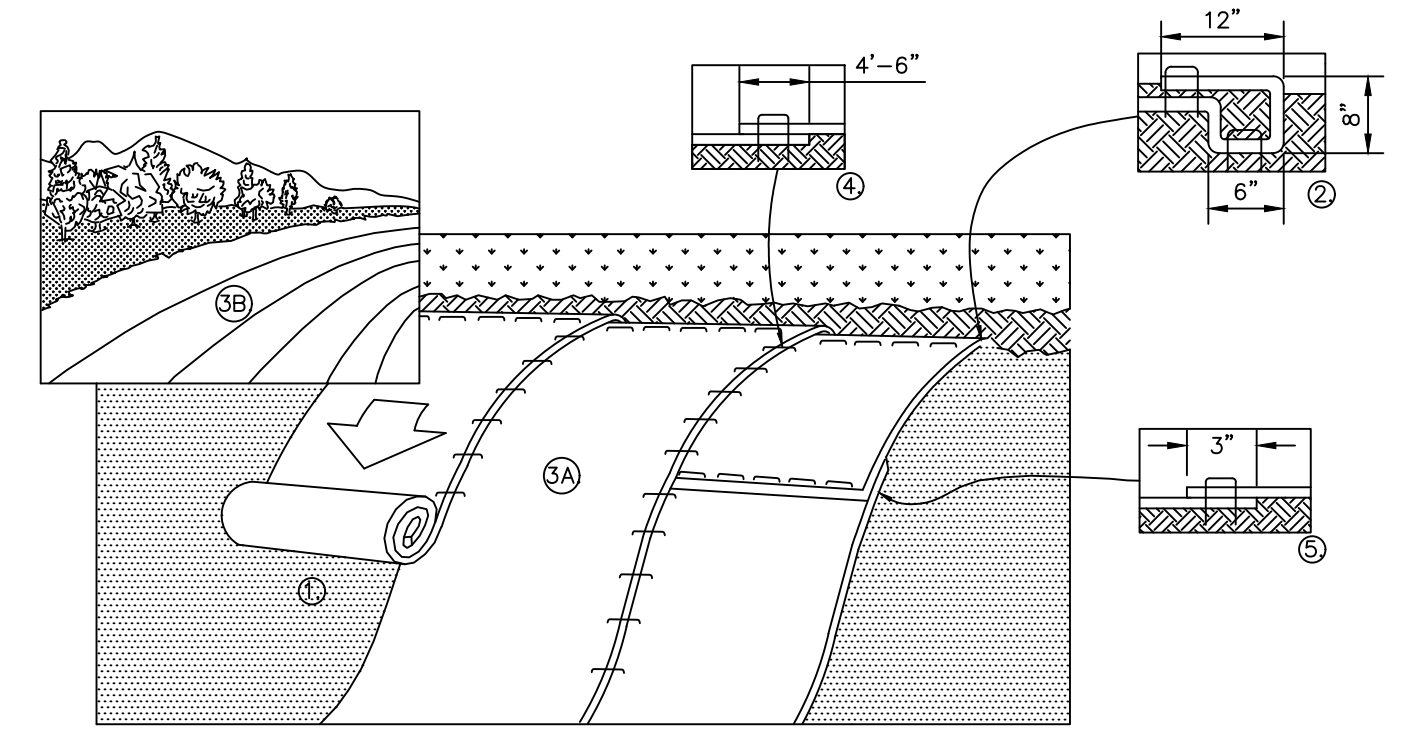
1. PREPARE SOIL BEFORE INSTALLING BLANKETS, INCLUDING ANY NECESSARY APPLICATION OF LIME, FERTILIZER, AND SEED.
2. BEGIN AT THE TOP OF THE SLOPE BY ANCHORING THE BLANKET IN A 6" DEEP X 6" WIDE TRENCH WITH APPROXIMATELY 12" OF BLANKET EXTENDED BEYOND THE UP-SLOPE PORTION OF THE TRENCH AS SHOWN IN DETAIL 2. ANCHOR THE BLANKET WITH A ROW OF STAPLES/STAKES APPROXIMATELY 12" APART IN THE BOTTOM OF THE TRENCH. BACKFILL AND COMPACT THE TRENCH AFTER STAPLING. APPLY SEED TO COMPACTED SOIL AND FOLD REMAINING 12" PORTION OF BLANKET BACK OVER SEED AND COMPACTED SOIL. SECURE BLANKET OVER COMPACTED SOIL WITH A ROW OF STAPLES/STAKES SPACED APPROXIMATELY 12" APART ACROSS THE WIDTH OF THE BLANKET.

3. ROLL THE BLANKETS (A.) DOWN OR (B.) HORIZONTALLY ACROSS THE SLOPE. BLANKETS WILL UNROLL WITH APPROPRIATE SIDE AGAINST THE SOIL SURFACE. ALL BLANKETS MUST BE SECURELY FASTENED TO SOIL SURFACE BY PLACING STAPLES/STAKES IN APPROPRIATE LOCATIONS AS PER MANUFACTURER'S RECOMMENDATION.

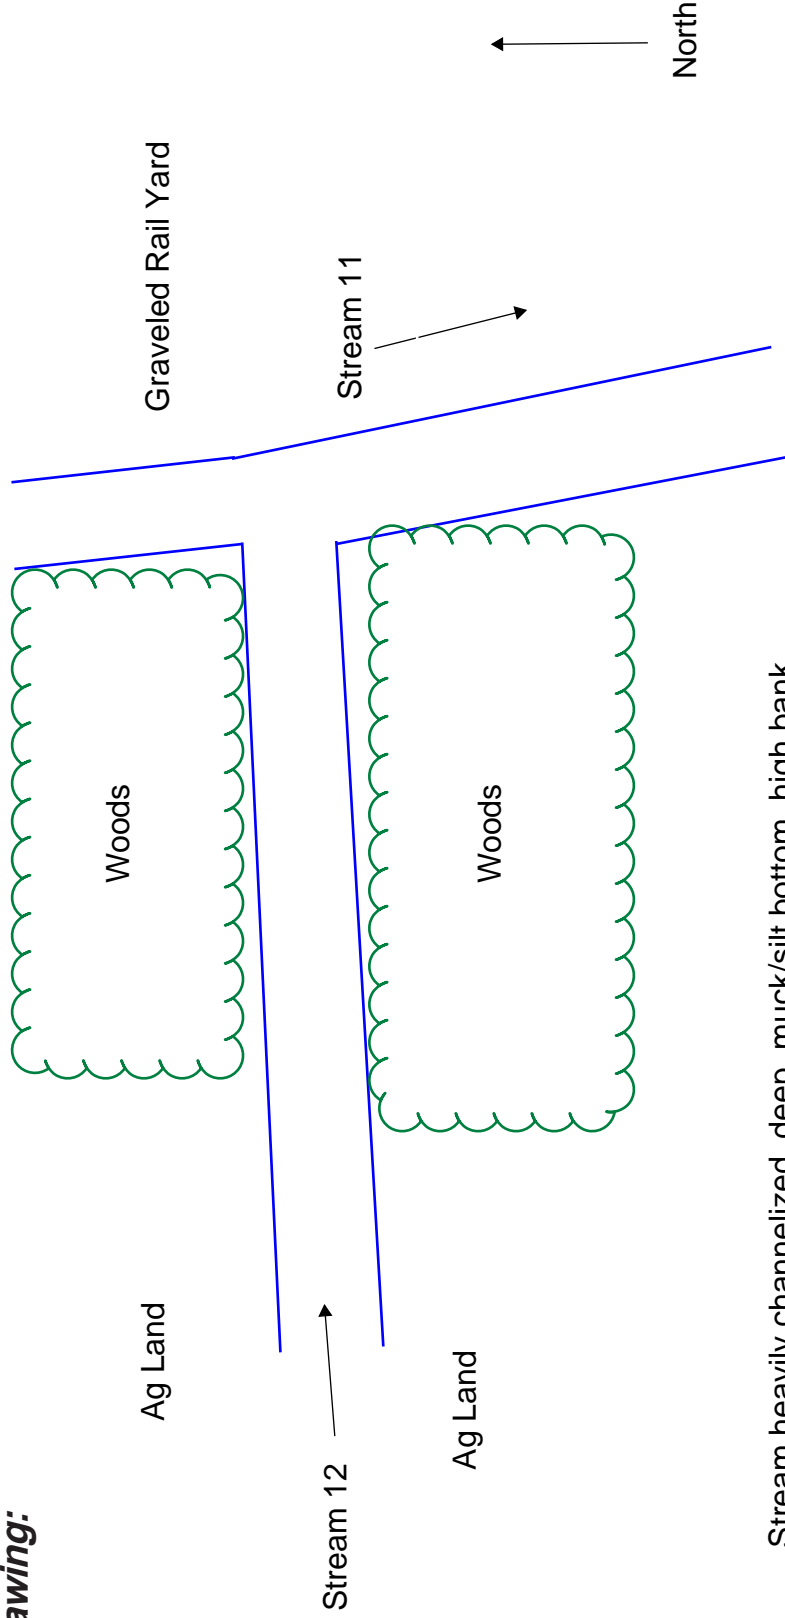
Stream Drawing:

Stream heavily channelized, deep, muck/silt bottom, high bank erosion, limited flow, all glide

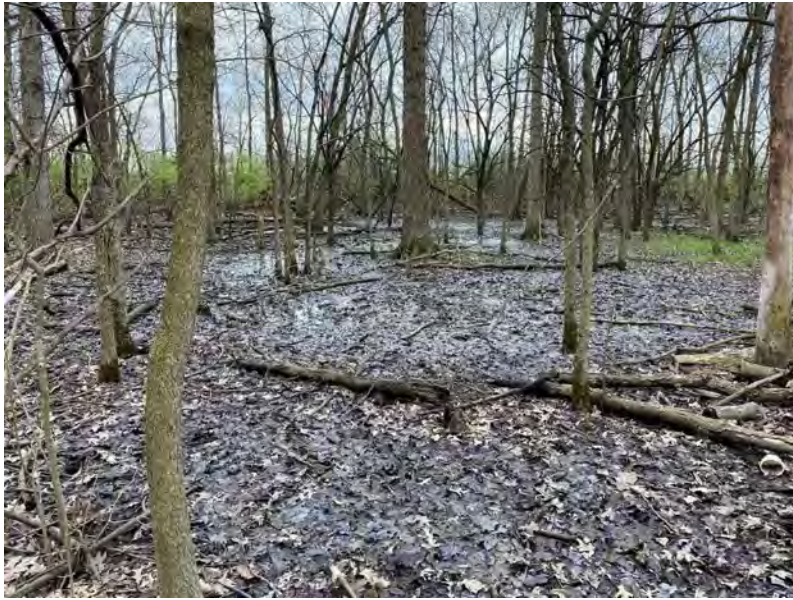
Photo 1: Representative view of forested Wetland 7 facing east. Photo taken April 9-13, 2021.

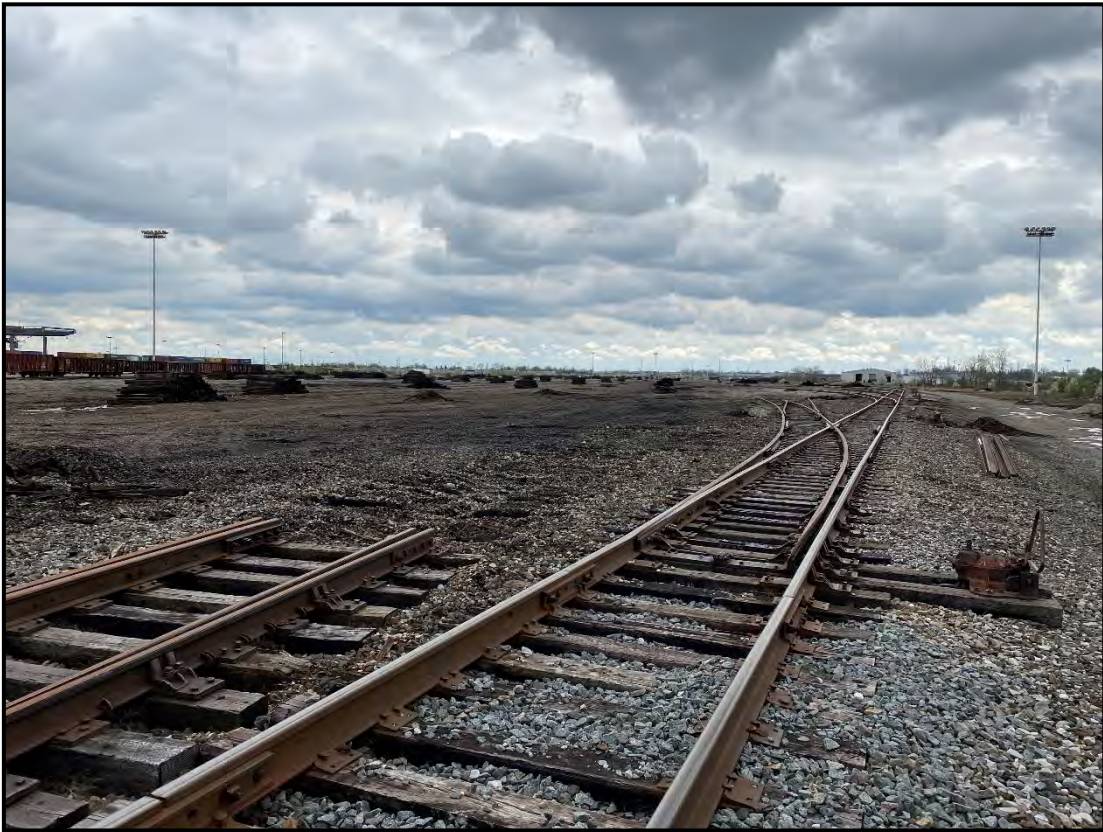
Photo 21 – Southerly view of former railroad lines observed throughout the evaluation area.

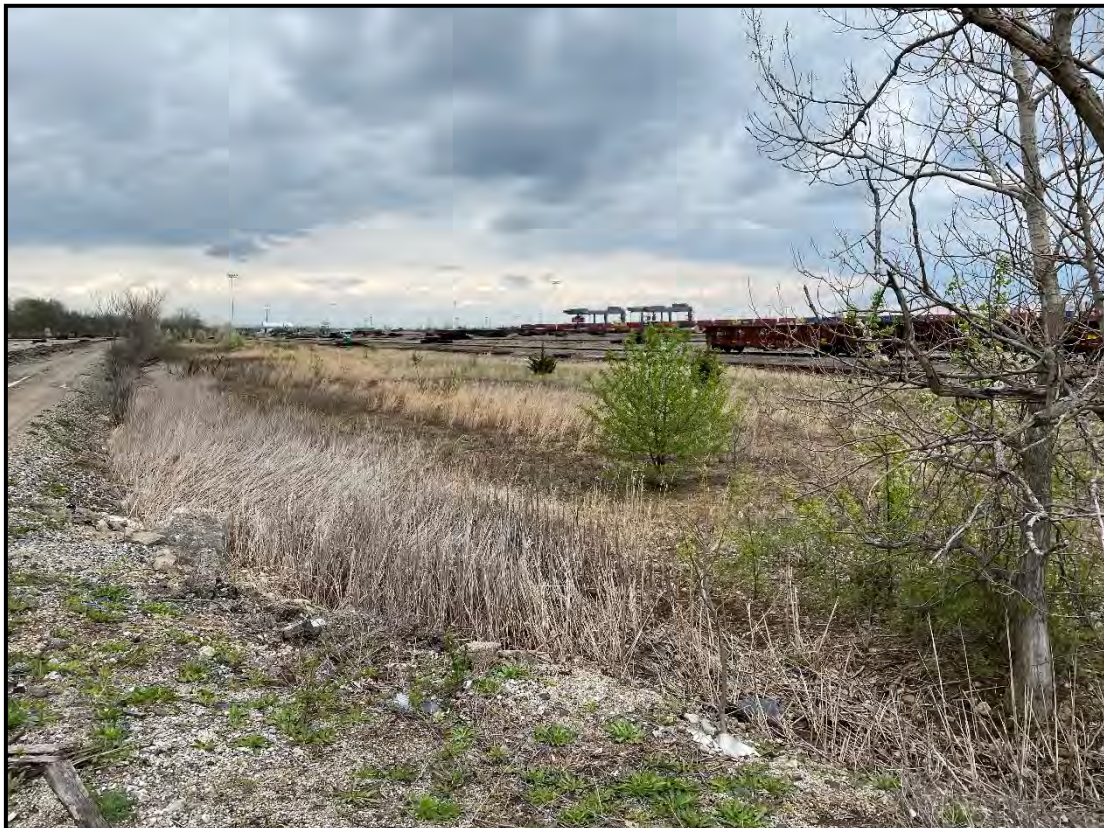
Photo 22 – Northeasterly view of former railroad lines and waste areas between tracks on the central part of the evaluation area.
