RE: City of Columbus Stormwater Drainage Manual (SWDM) Type III Variance Request Proposed Buckeye Rail Yard Redevelopment 4882 Trabue Road, Columbus, Franklin County, Ohio 43228

Appendix E: Stream Relocation Construct	ion Plan(s)

# BUCKEYE YARD STREAM CORRIDOR PROTECTION ZONE REFORESTATION PLANS

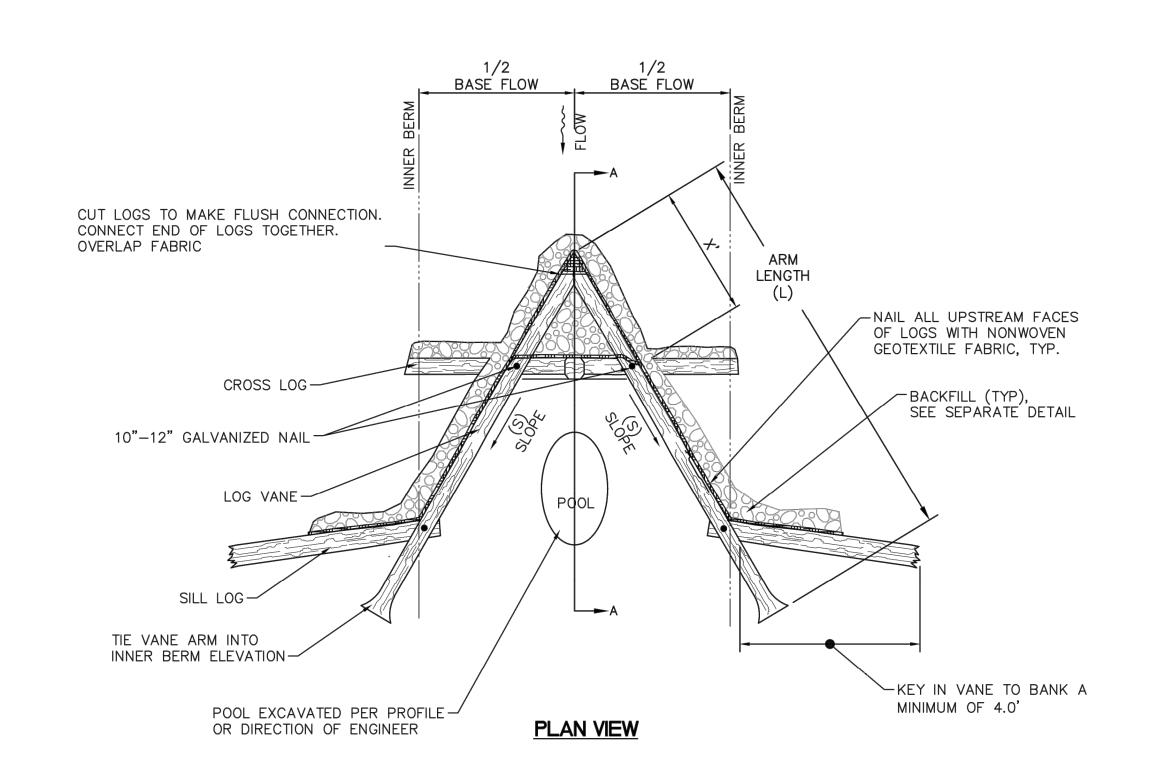
#### SECTION A-A

- 1. PLACE FABRIC ON THE UPSTREAM SIDE OF THE MOST UPSTREAM LOG SILL IN THE CONSTRUCTED RIFFLE.
- BOULDERS SHALL BE USED TO ANCHOR LOGS IF NEEDED.
   LOG SILLS SHALL OVERLAP AND ANCHOR THE LOG SILL DIRECTLY
- UPSTREAM. 4. THE LOG SILL SHALL ALL BE DESIGNED TO BE SUBMERGED OR COVERED AT LOW FLOWS.

5. BOULDERS SHALL BE 18" MIN.
- 6. AFTER ENGINEER HAS ACCEPTED STRUCTURE, THE NONWOVEN GEOTEXTILE FABRIC SHOULD BE TRIMMED TO MINIMIZE THE AMOUNT VISIBLE ON TOP OF LOG.

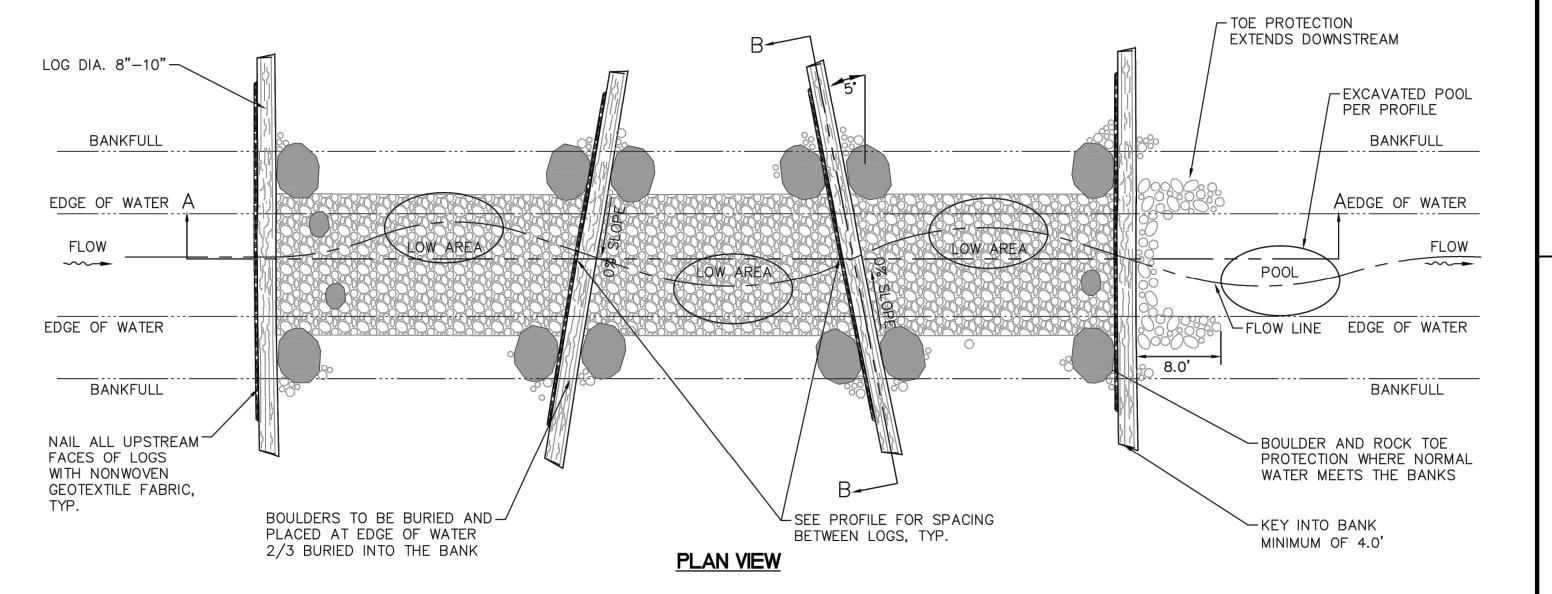
## LOG CROSS VANE **NOT TO SCALE**

REACH	WBRR TRIE
ARM LENGTH (L)	15'
ARM TIE-IN HEIGHT	0.3'
ARM SLOPE (S)	1.0%-2.0%
STEP SPACING (X)	5'

DEEPEST PART OF POOL TO BE IN LINE WITH WHERE VANE ARM TIES INTO THE BANK. BACKFILL MIX TO BE USED TO REDUCE VOIDS BETWEEN LOGS.
ALL LOGS TO BE HARDWOOD SPECIES, 8"-10" DIAMETER MINIMUM.

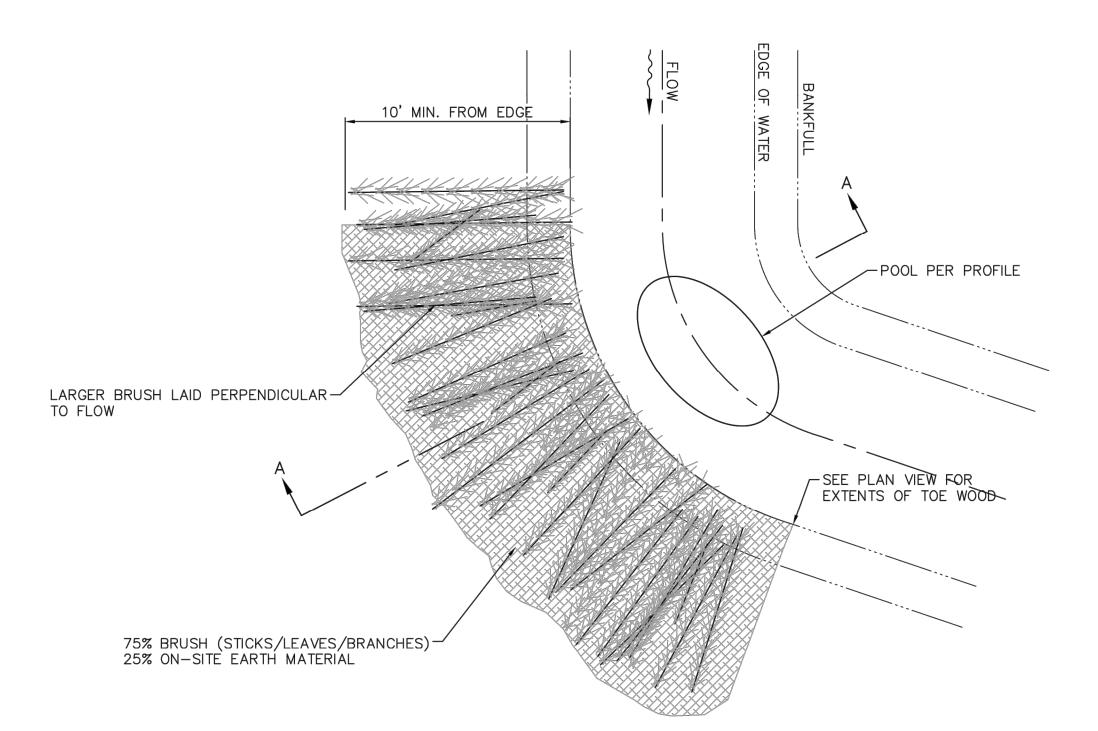
- 1. BRUSH SHALL BE A VARIETY OF DIAMETERS AND SHALL BE LAID GENERALLY PERPENDICULAR TO FLOW AND COMPACTED BY DIRT.
- 2. FIRST LAYER OF BRUSH SHALL BE A BED OF 3"
  LIMBS/BRUSH SET 18" MIN. BELOW THE BED.

3. LAYERS ABOVE 1st LAYER SHALL BE 75% BRUSH OF A
  VARIETY OF SIZES WITH 25% ON SITE MATERIAL FILLING
- 4. BRUSH BROUGHT UP IN LIFTS.5. GRADING ABOVE THE TOE WOOD PER THE TYPICAL SECTION AND/OR GRADING PLAN.

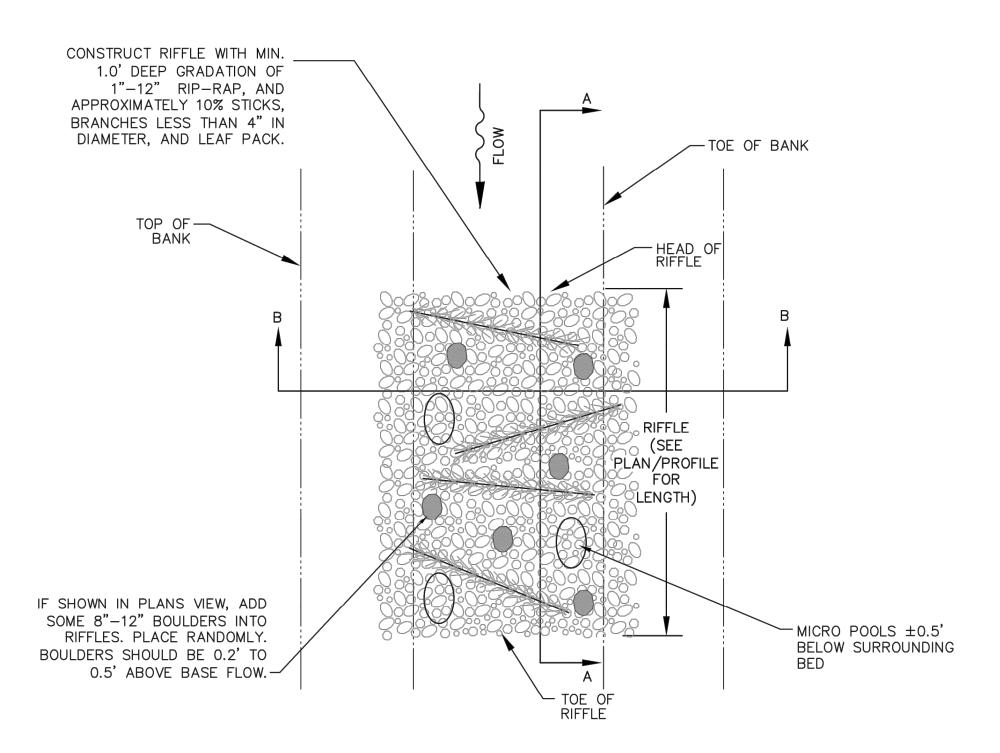
## **CONSTRUCTED RIFFLE NOT TO SCALE**

#### HEAD OF—— RIFFLE - SEE PLANS FOR ELEVATION - TOE OF RIFFLE POOL SEE PLAN EXTEND RIP-RAP AND PROFILE 5' MIN UPSTREAM INTO GLIDE -EXTEND RIFFLE 10' SECTION A-A MIN INTO RUN

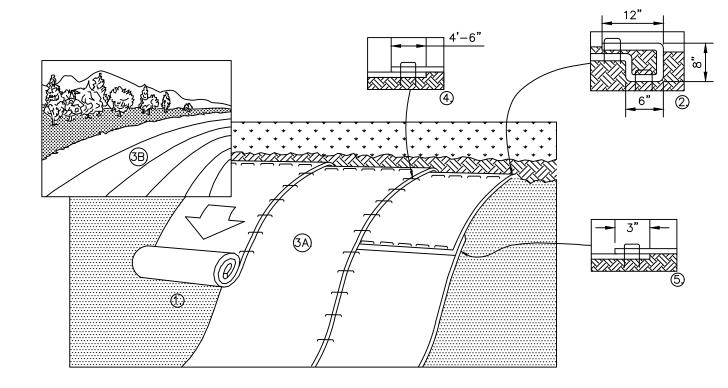
- PREPARE SOIL BEFORE INSTALLING BLANKETS, INCLUDING ANY NECESSARY APPLICATION OF LIME, FERTILIZER, AND SEED. BEGIN AT THE TOP OF THE SLOPE BY ANCHORING THE BLANKET IN A 6" DEEP X 6" WIDE TRENCH WITH APPROXIMATELY 12" OF BLANKET EXTENDED BEYOND THE UP-SLOPE PORTION OF THE TRENCH AS SHOWN IN DETAIL 2. ANCHOR THE BLANKET WITH A ROW OF STAPLES/STAKES APPROXIMATELY 12" APART IN THE BOTTOM OF THE TRENCH. BACKFILL AND COMPACT THE TRENCH AFTER STAPLING. APPLY SEED TO COMPACTED SOIL AND FOLD REMAINING 12" PORTION OF BLANKET BACK OVER SEED AND COMPACTED SOIL. SECURE BLANKET OVER COMPACTED SOIL WITH A ROW OF STAPLES/STAKES SPACED APPROXIMATELY 12" APART ACROSS THE WIDTH OF THE BLANKET.

- ROLL THE BLANKETS (A.) DOWN OR (B.) HORIZONTALLY ACROSS THE SLOPE. BLANKETS WILL UNROLL WITH APPROPRIATE SIDE AGAINST THE SOIL SURFACE. ALL BLANKETS MUST BE SECURELY FASTENED TO SOIL SURFACE BY PLACING STAPLES/STAKES IN APPROPRIATE LOCATIONS AS PER MANUFACTURES RECOMMENDATION.

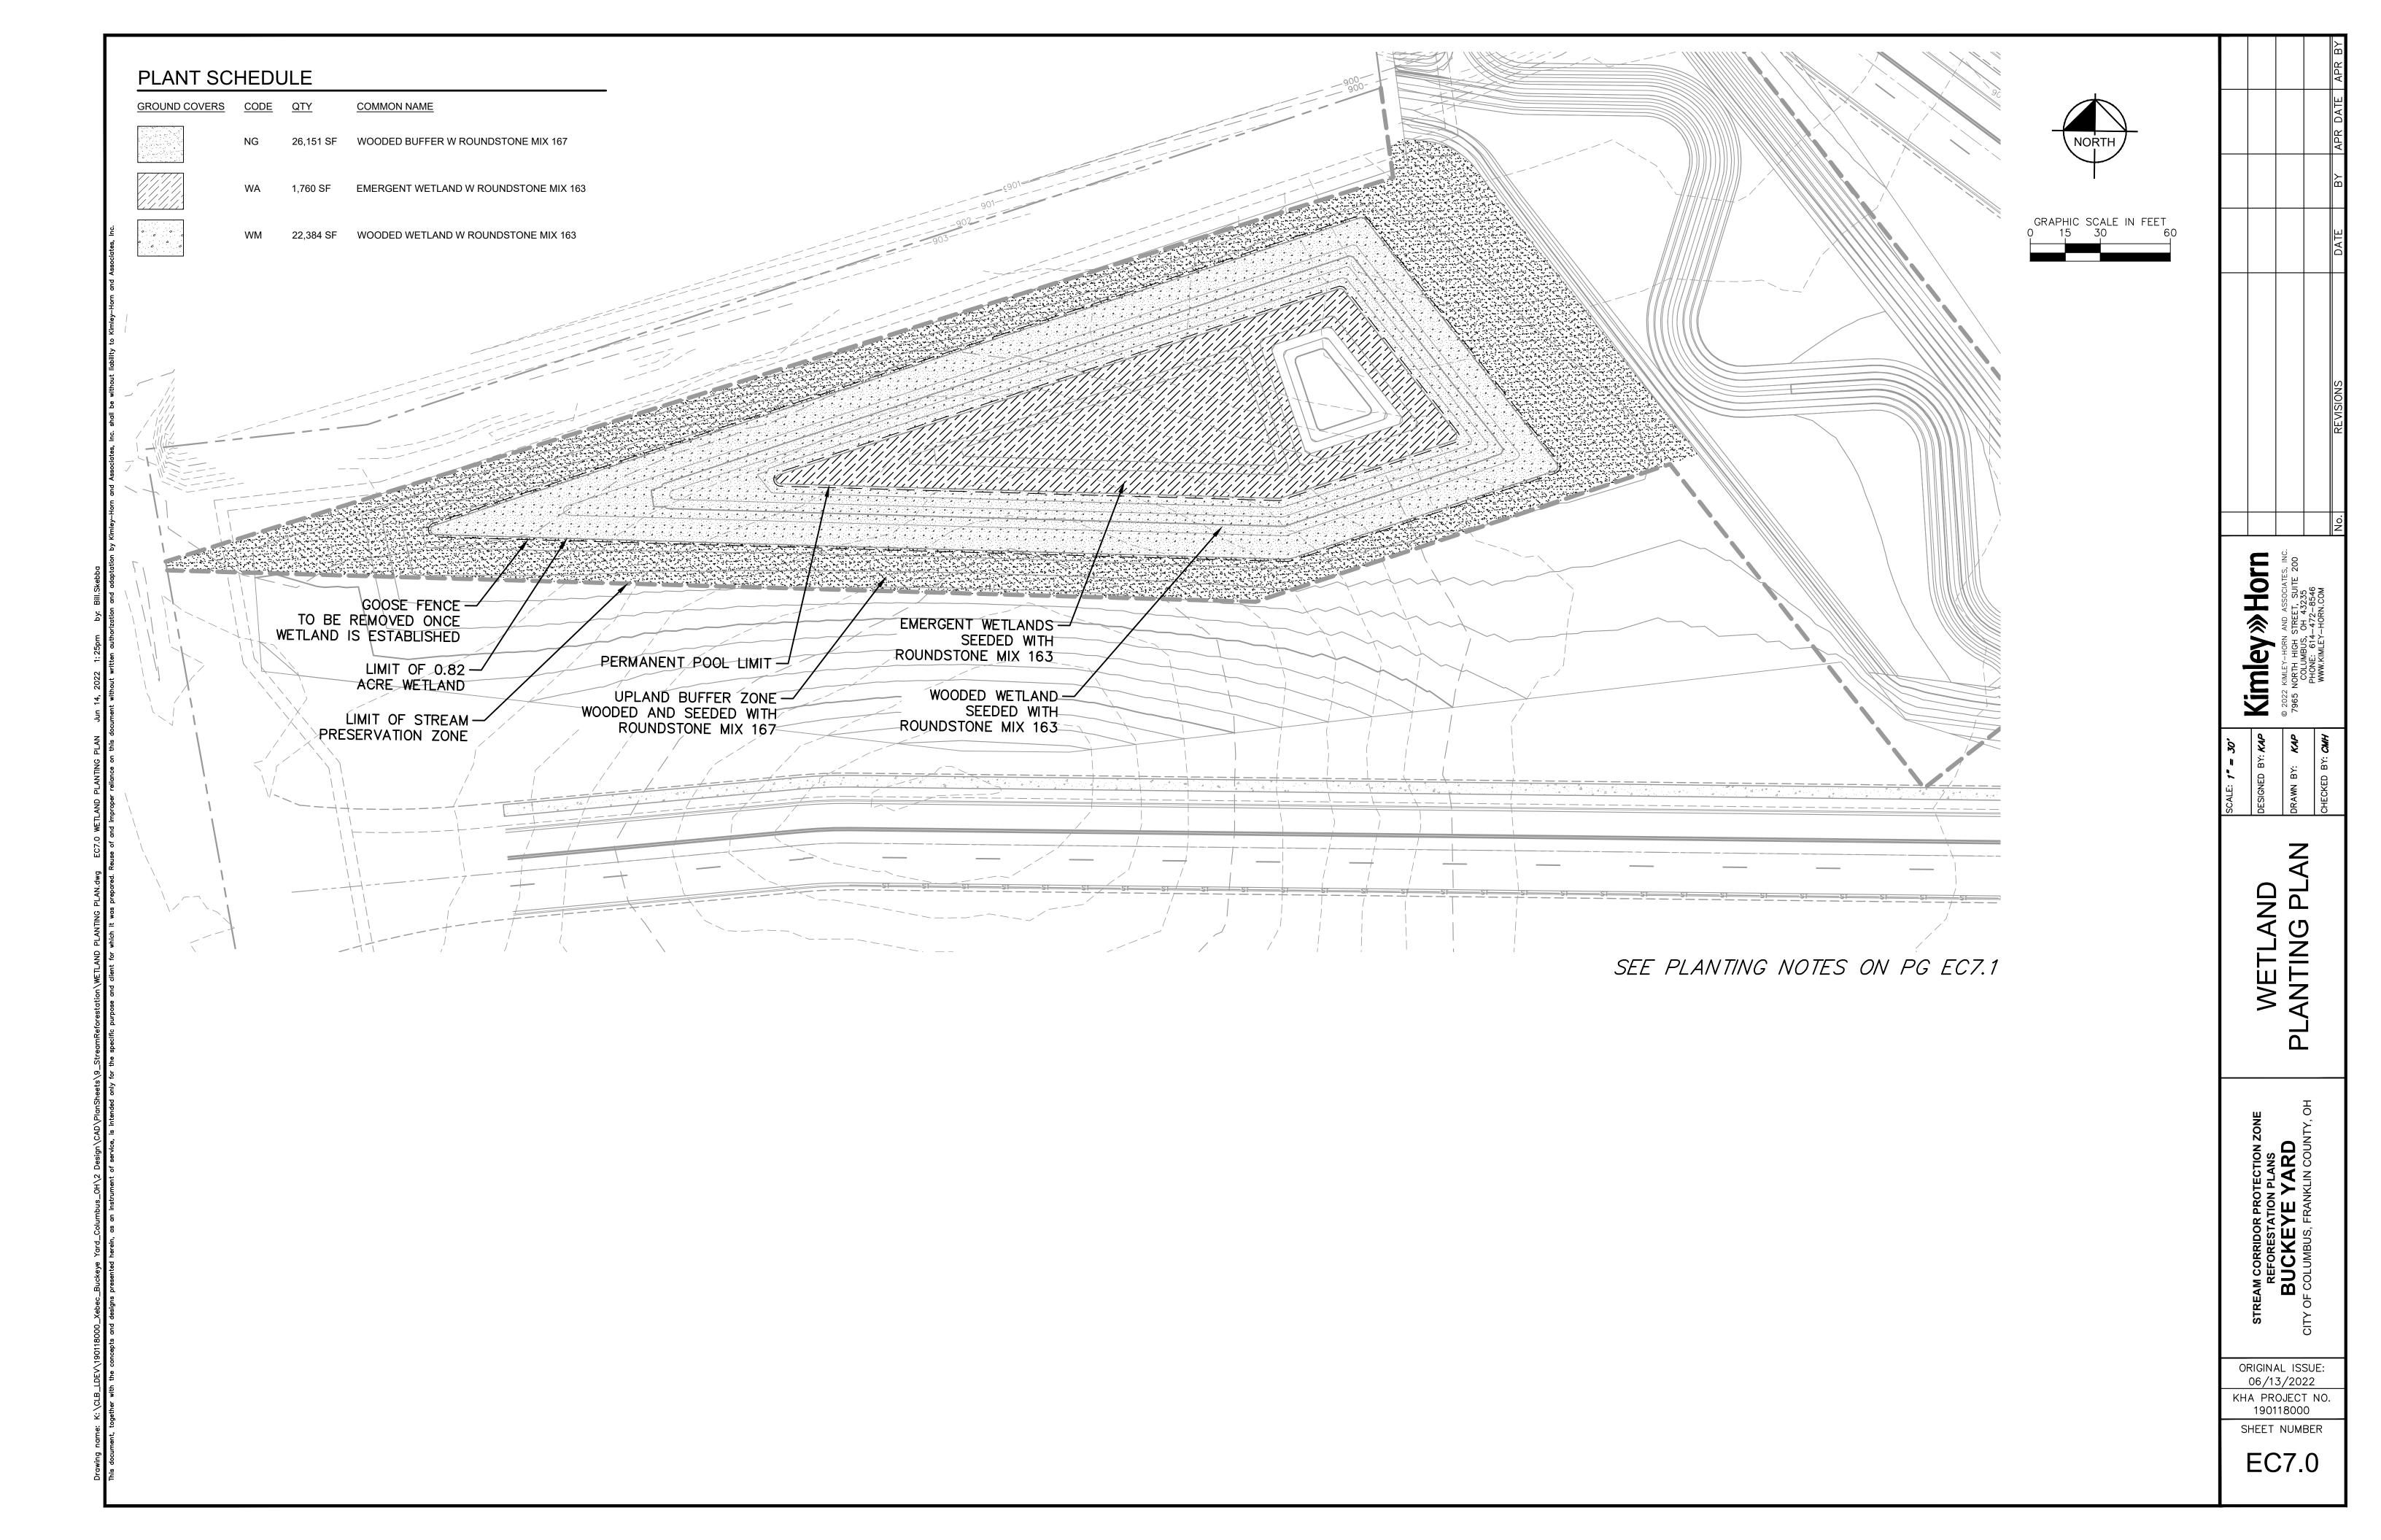
#### WETLAND PLANTING NOTES

A MINIMUM OF 400 NATIVE, LIVE, AND HEALTHY (DISEASE AND PEST FREE) WOODY PLANTS PER ACRE WITHIN THE WOODED WETLAND PORTION (OF WHICH AT LEAST 200 ARE TREE SPECIES) WILL BE PRESENT AT THE END OF THE MONITORING PERIOD.

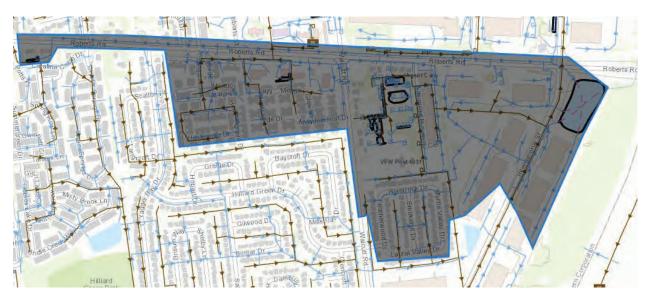
Stream 9 part 1

0.21 square miles

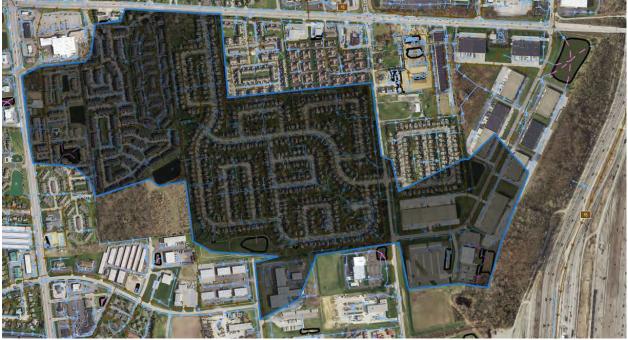
Stream 9 part 2

0.36 square miles

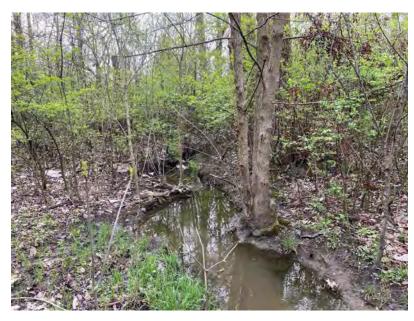
Photo 17: Representative view of the western portion of Stream 9 facing east (downstream).

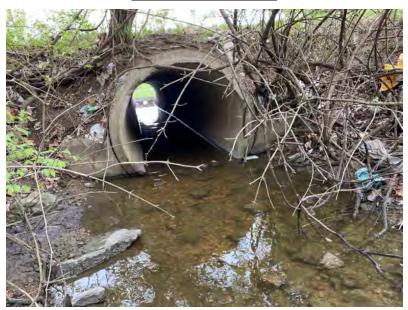
Photo 18: Representative view of western portion of Stream 9 facing west (upstream) toward western stormwater basin. Photo taken April 9-12, 2021.

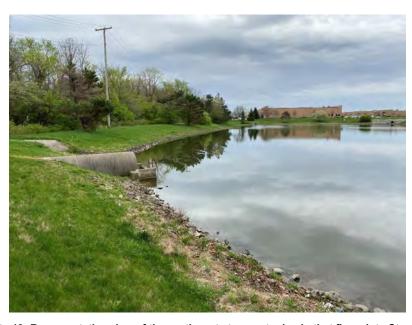
Photo 19: Representative view of the northwest stormwater basin that flows into Stream 9, located just west of the Site. Photo taken April 9-12, 2021.

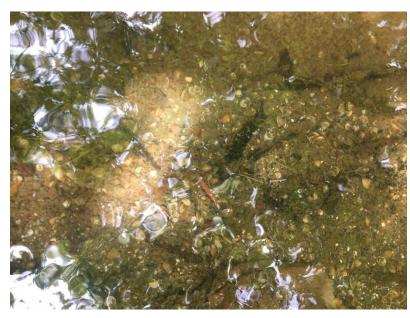
Photo 21: Representative view of Stream 9 channel bottom substrate (silt/detritus and Asian fingernail clams). Photo taken August 30, 2021.

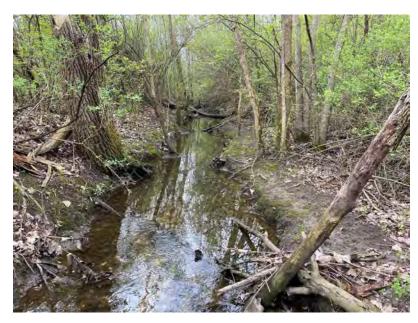
Photo 25: Representative view of Stream 10 facing upstream (south). Photo taken April 9-12, 2021.

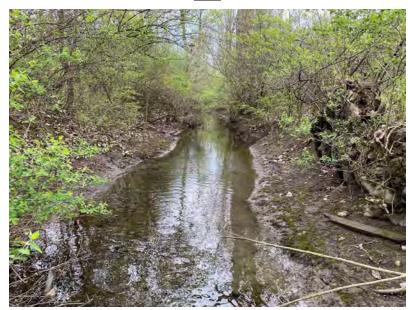
Photo 26: Representative view of Stream 10 facing downstream (north) photo taken April 9-12, 2021.

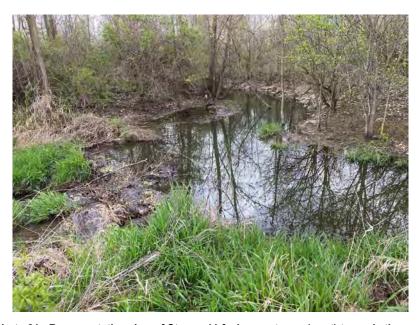
Photo 31: Representative view of Stream 11 facing upstream (west) towards the west adjoining property. Photo taken April 9-12, 2021.

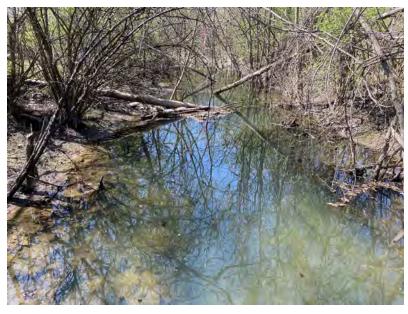
Photo 32: Representative view of Stream 11 facing downstream (east) as it flows onto the Site. Photo taken April 9-12, 2021.

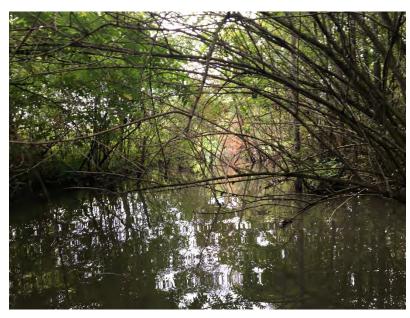
Photo 33: Representative view of the central portion of Stream 11 facing upstream (west),
Photo taken August 30, 2021.

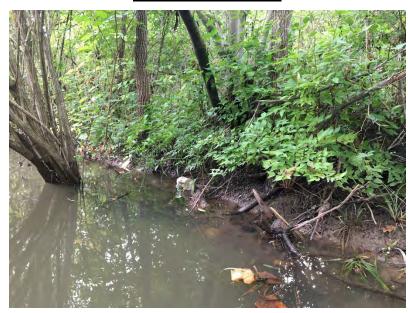
Photo 34: Representative view of the central portion of Stream 11 facing western stream bank. Channel is extremely deep in this location; bottom substrate is unconsolidated muck/silt with no flow. Photo taken August 30, 2021.

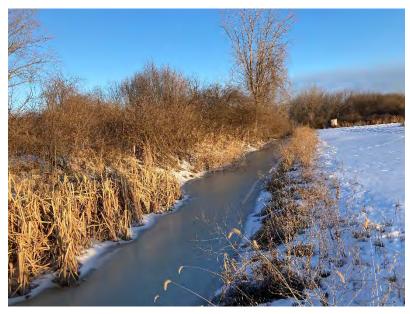
Photo 36: View of the northern portion of Stream 11 (just north of Stream 12) facing upstream (north). Photo taken February 10, 2022.

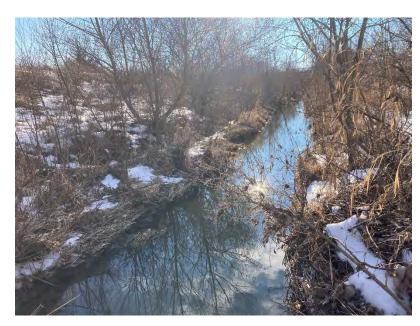
Photo 36: Representative view of the southwest portion of Stream 11 (southeast of access road crossing) facing downstream (south). Photo taken February 10, 2022.

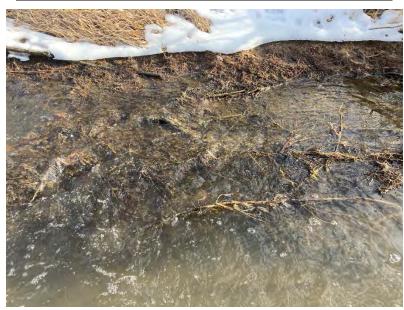
Photo 37: Representative view of southwest portion of Stream 11 channel bottom substrate (southeast of access road crossing). Photo taken February 10, 2022.

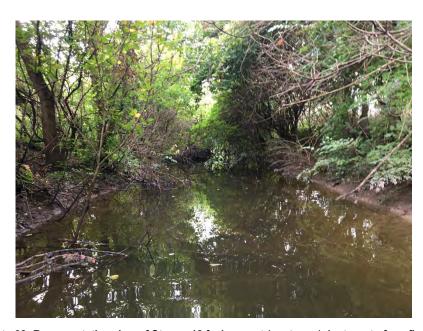
Photo 38: Representative view of Stream 12 facing west (upstream), just west of confluence with Stream 11. Photo taken August 30, 2021.

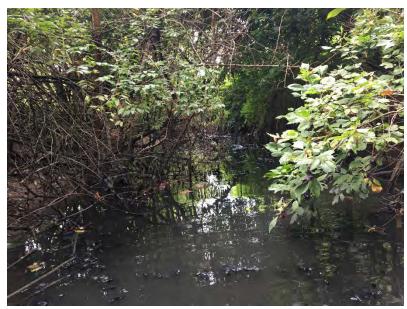
Photo 39: Representative view of Stream 12 facing east (downstream), just west of confluence with Stream 11. Photo taken August 30, 2021.

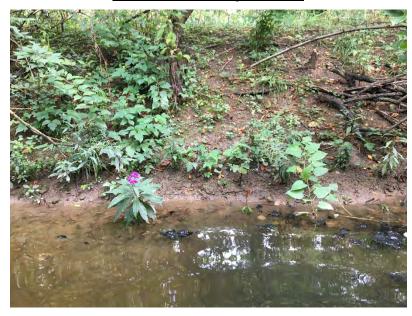
Photo 41: Representative view of the central portion of Stream 12 facing north stream bank.

Channel is extremely deep in this location; bottom substrate is unconsolidated muck/silt with no flow. Photo taken August 30, 2021.

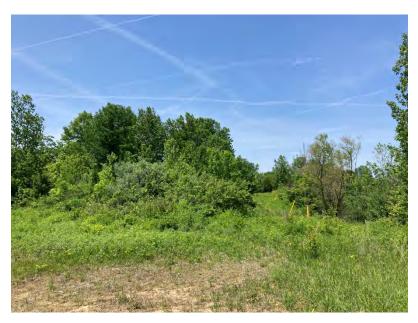
Photo 1: View of the Stream 13 corridor (shrub area) facing north. Photo taken just southwest of where Stream 13 flows east into Stream 11 (near yellow pipeline markers).

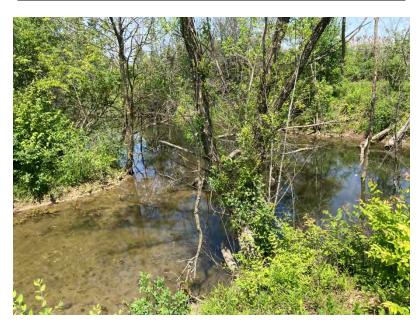
Photo 2: View of the confluence of Stream 13 (left side) as it flows east (downstream) into Stream 11. Stream 11 is impounded at this located due to beaver dams.

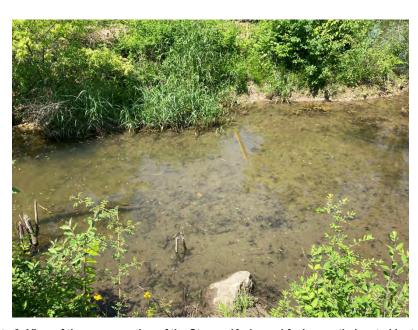
Photo 3: View of the cross section of the Stream 13 channel facing north, located just west (upstream) of the confluence with Stream 11.

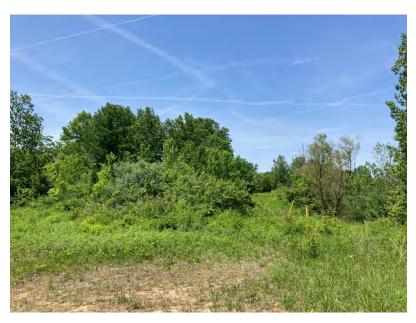
Photo 1: View of the Stream 13 corridor (shrub area) facing north. Photo taken just southwest of where Stream 13 flows east into Stream 11 (near yellow pipeline markers).

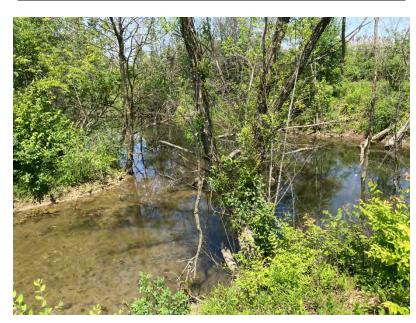
Photo 2: View of the confluence of Stream 13 (left side) as it flows east (downstream) into Stream 11. Stream 11 is impounded at this located due to beaver dams.

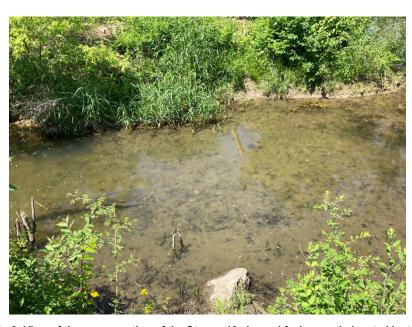
Photo 3: View of the cross section of the Stream 13 channel facing north, located just west (upstream) of the confluence with Stream 11.

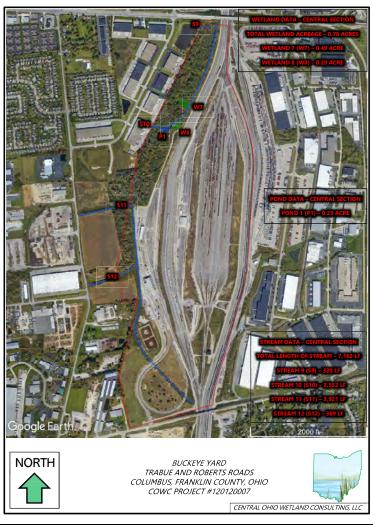
WETLAND AND STREAM DELINEATION MAP

Wetland 7 is located within the wooded northwest part of the evaluation area. According to the USDA web soil survey map, this wetland is located within hydric Kokomo silty clay loam soils. Wetland 7 is mapped with a PFO1A designation on the NWI map. The wetland appears to receive hydrology from precipitation, overland flow from adjacent uplands, and flood waters from Stream 10. Stream 10 abuts the east side of the wetland and appears to provide surface water to Wetland 7 during prolonged precipitation events. Based on visual observation, Wetland 7 appears to be regularly inundated/saturated. Wetland 7 is generally dominated by American Elm (Ulmus americana), Swamp White Oak (Quercus bicolor), and Green Ash (Fraxinus pennsylvanica). The wetland scored 49 points, placing this wetland in Category 2.

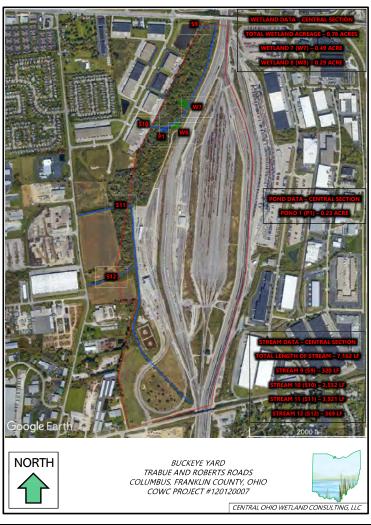
WETLAND AND STREAM DELINEATION MAP

Wetland 8 is located within the wooded northwest part of the evaluation area. According to the USDA web soil survey map, this wetland is located within hydric Kokomo silty clay loam soils. The wetland appears to receive hydrology from precipitation, overland flow from adjacent uplands, and flood waters from Stream 10. Stream 10 abuts the north side of the wetland and appears to provide surface water to Wetland 8 during prolonged precipitation events. Based on visual observation, Wetland 8 appears to be seasonally saturated. Wetland 8 is generally dominated by Reed Canary Grass (Phalaris arundinacea) and Black Willow (Salix nigra). The wetland scored 38 points, placing this wetland in Category 2.

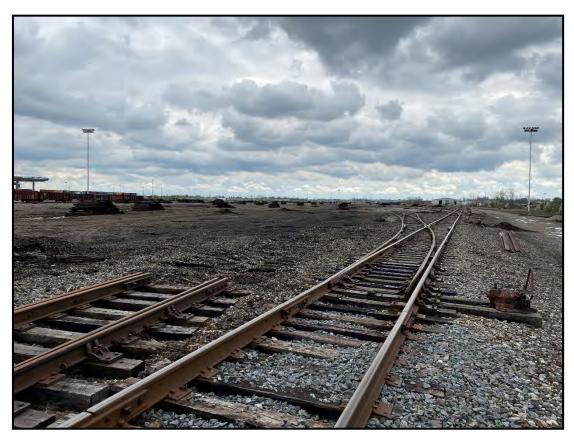
Photo 21 – Southerly view of former railroad lines observed throughout the evaluation area.

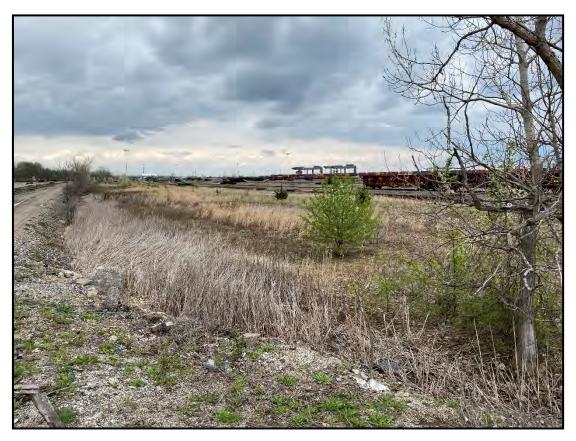
Photo 22 – Northeasterly view of former railroad lines and waste areas between tracks on the central part of the evaluation area.

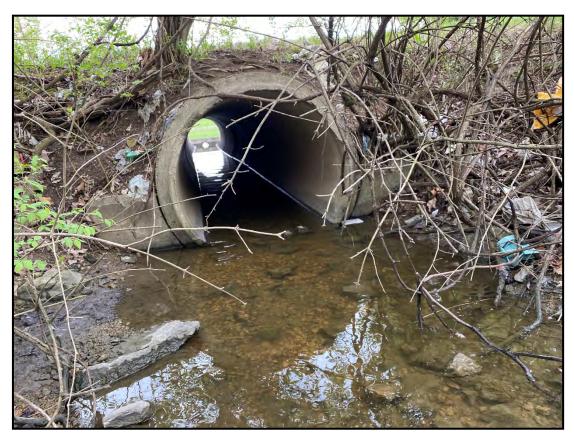
Photo 29 – Westerly view at the origination of Stream 9. This culvert pipe discharges surface water from a west adjoining storm water management pond.

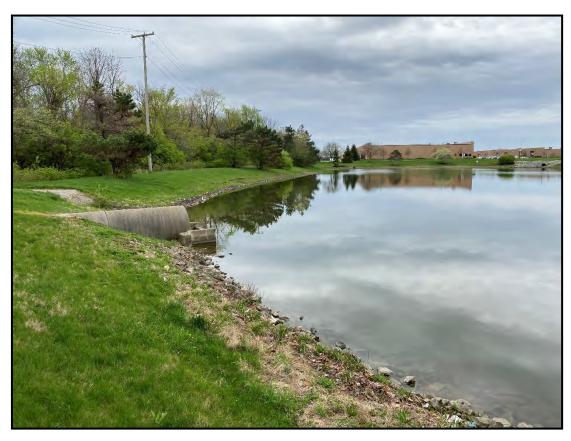
Photo 30 – Southwesterly view at the west adjoining storm water management pond directing surface water to Stream 9.

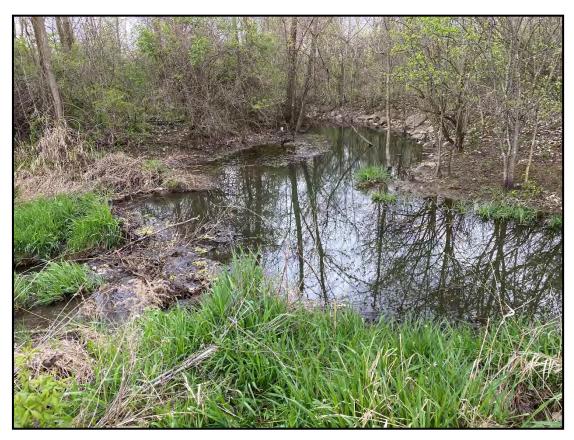
Photo 43 – Northwesterly view of Stream 11 on the west central part of the evaluation area.

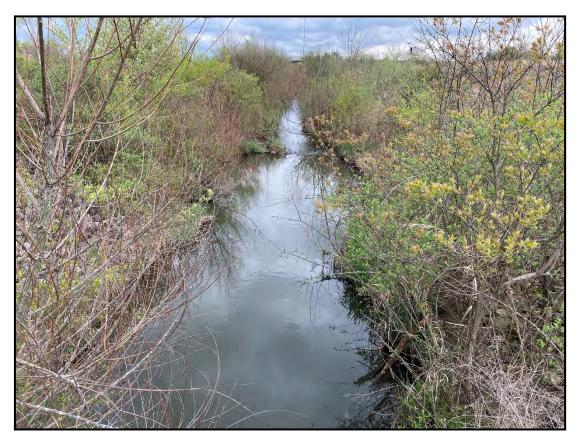
Photo 44 – Southeasterly view of Stream 11 as it crosses the southwest part of the evaluation area.
